CITY OF DURHAM + DURHAM OUTDOOR AQUATICS STUDY

WHEELS FUN PARK RINK - CODE ANALYSIS

AUGUST 19, 2022

Wheels Recreation Center

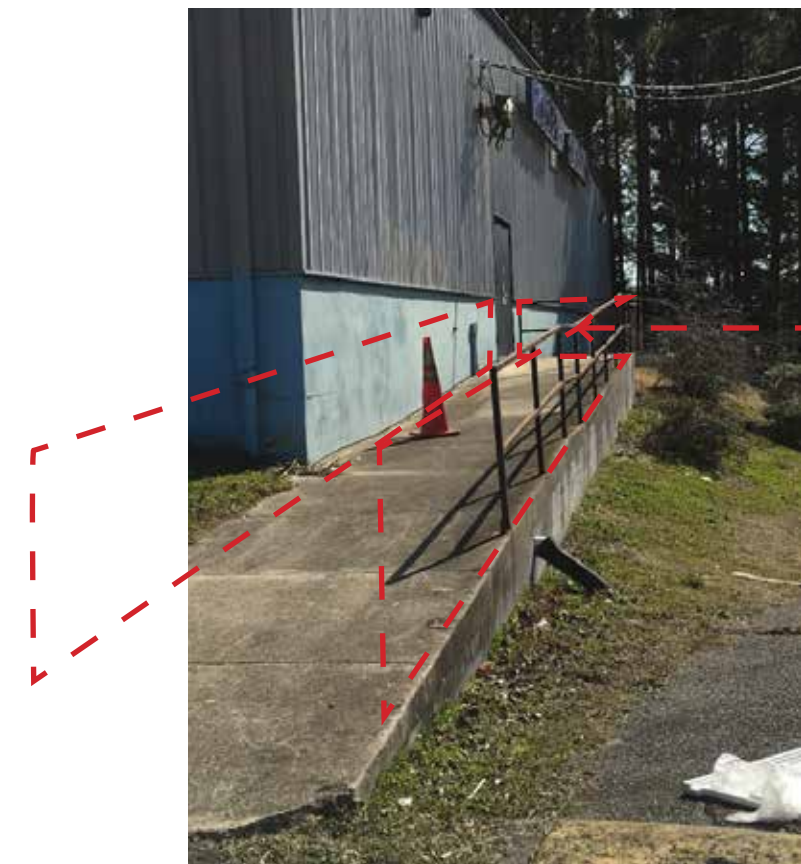
NEW COMPLIANT
HANDRAIL NEEDED ON
BOTH SIDES OF RUNS
>5% SLOPE

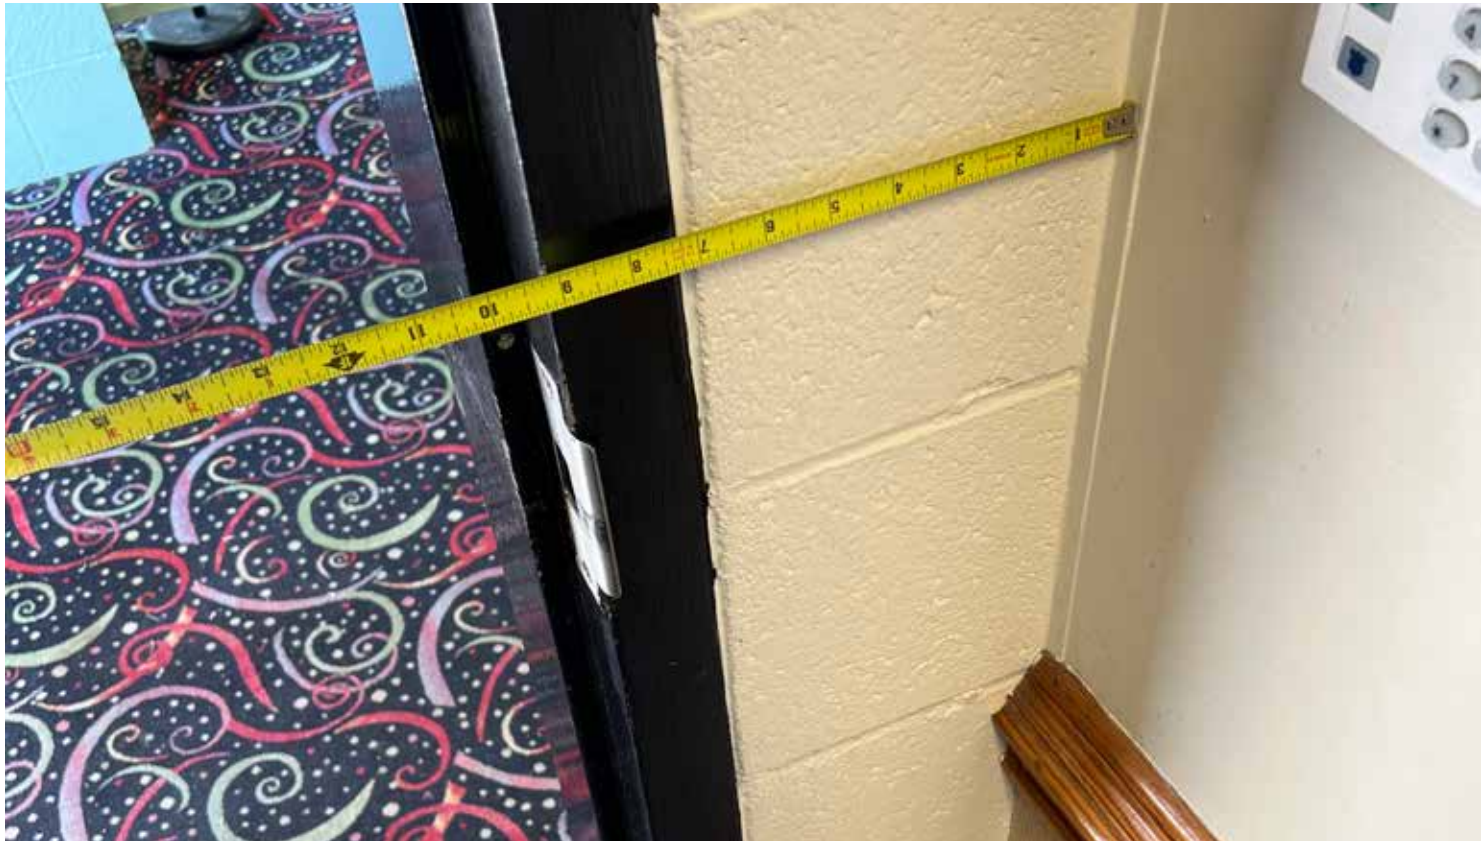
- The “pull” clearance on the office door does not meet the 18” clear dimension. The adjacent trophy display wall will need to be shifted by 10”. [2017 ICC A117.1 - Section 404]
- Door hardware on each of the three office doors will need to be replaced from knobs to levers. [2017 ICC A117.1 - Section 309]

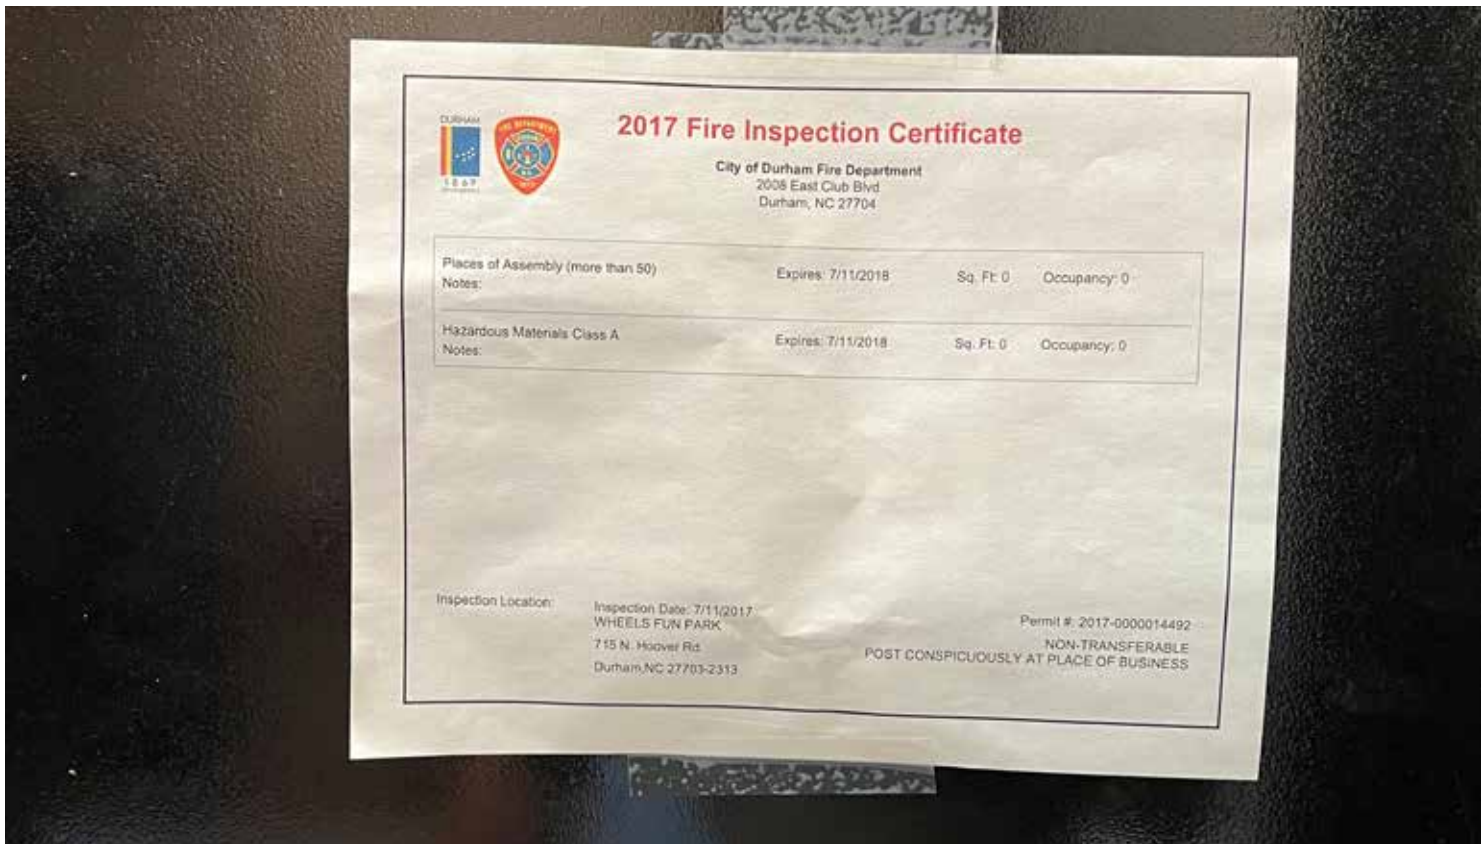
- Investigate when the most recent fire inspection was completed and if the building has met those requirements.

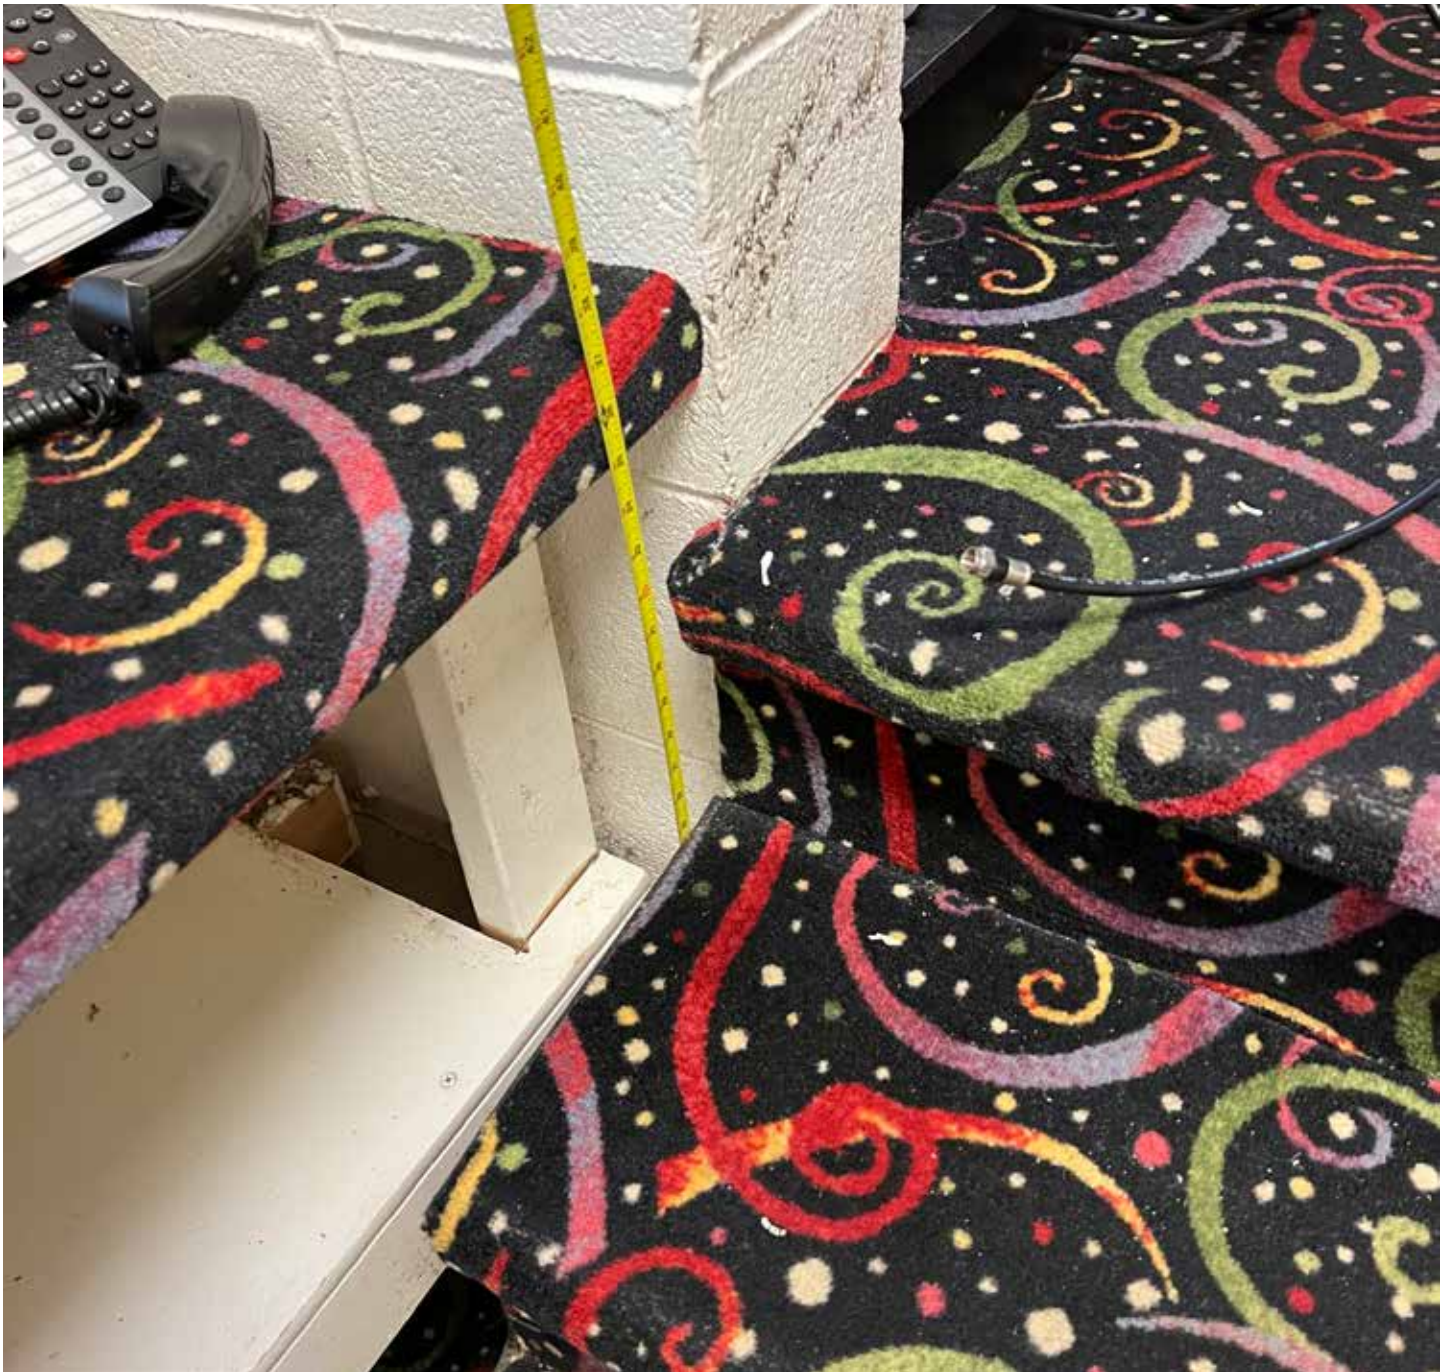
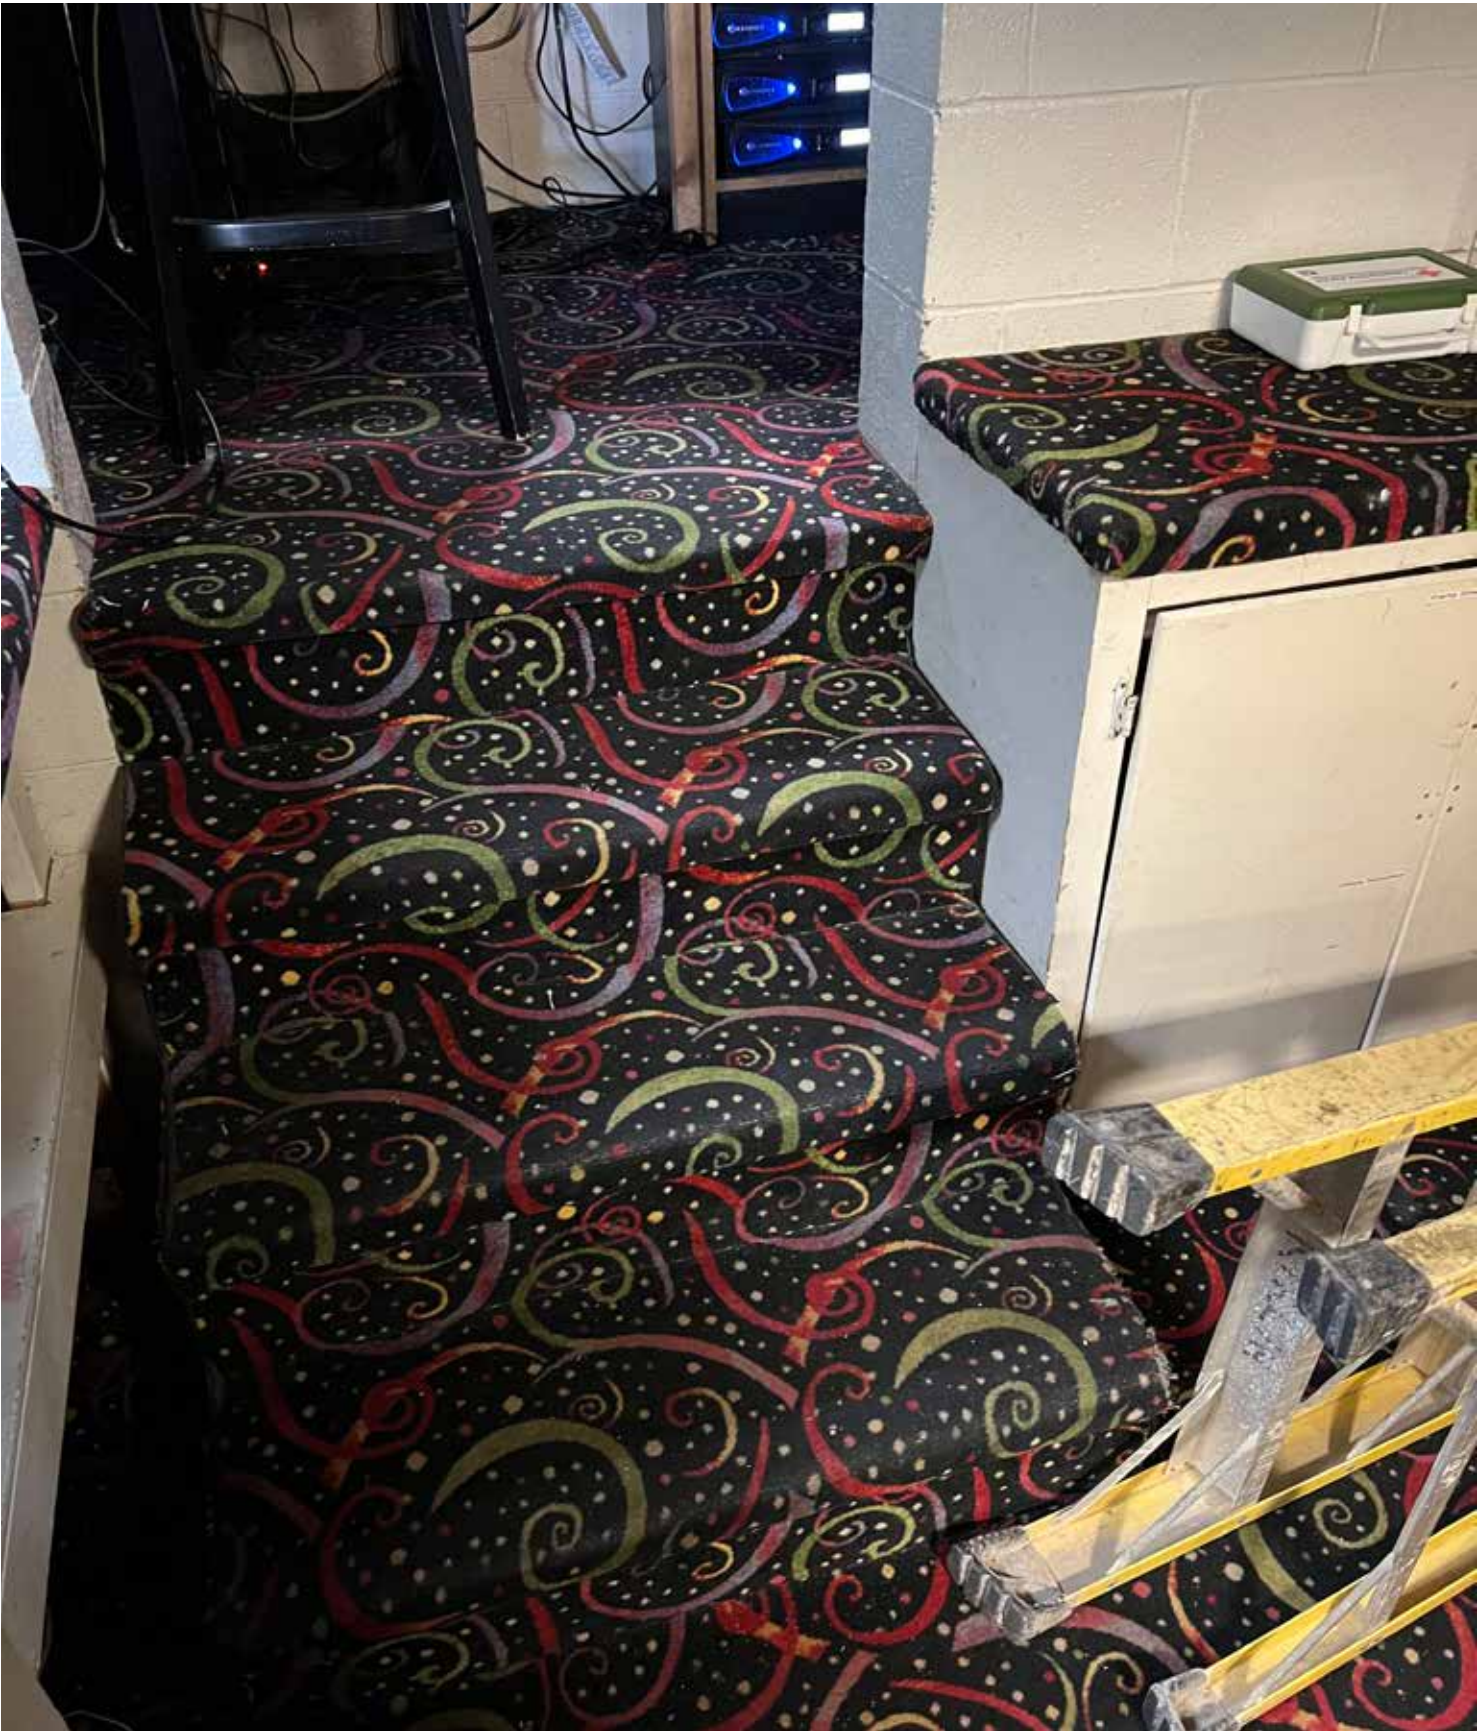
- The DJ booth area is not accessible. The platform does not have an accessible route and does not have the proper floor clearance for turning space. It would be recommended to enlarge this area, relocate, or alter to provide accessibility. [2017 ICC A117.1 - Section 304, 406]

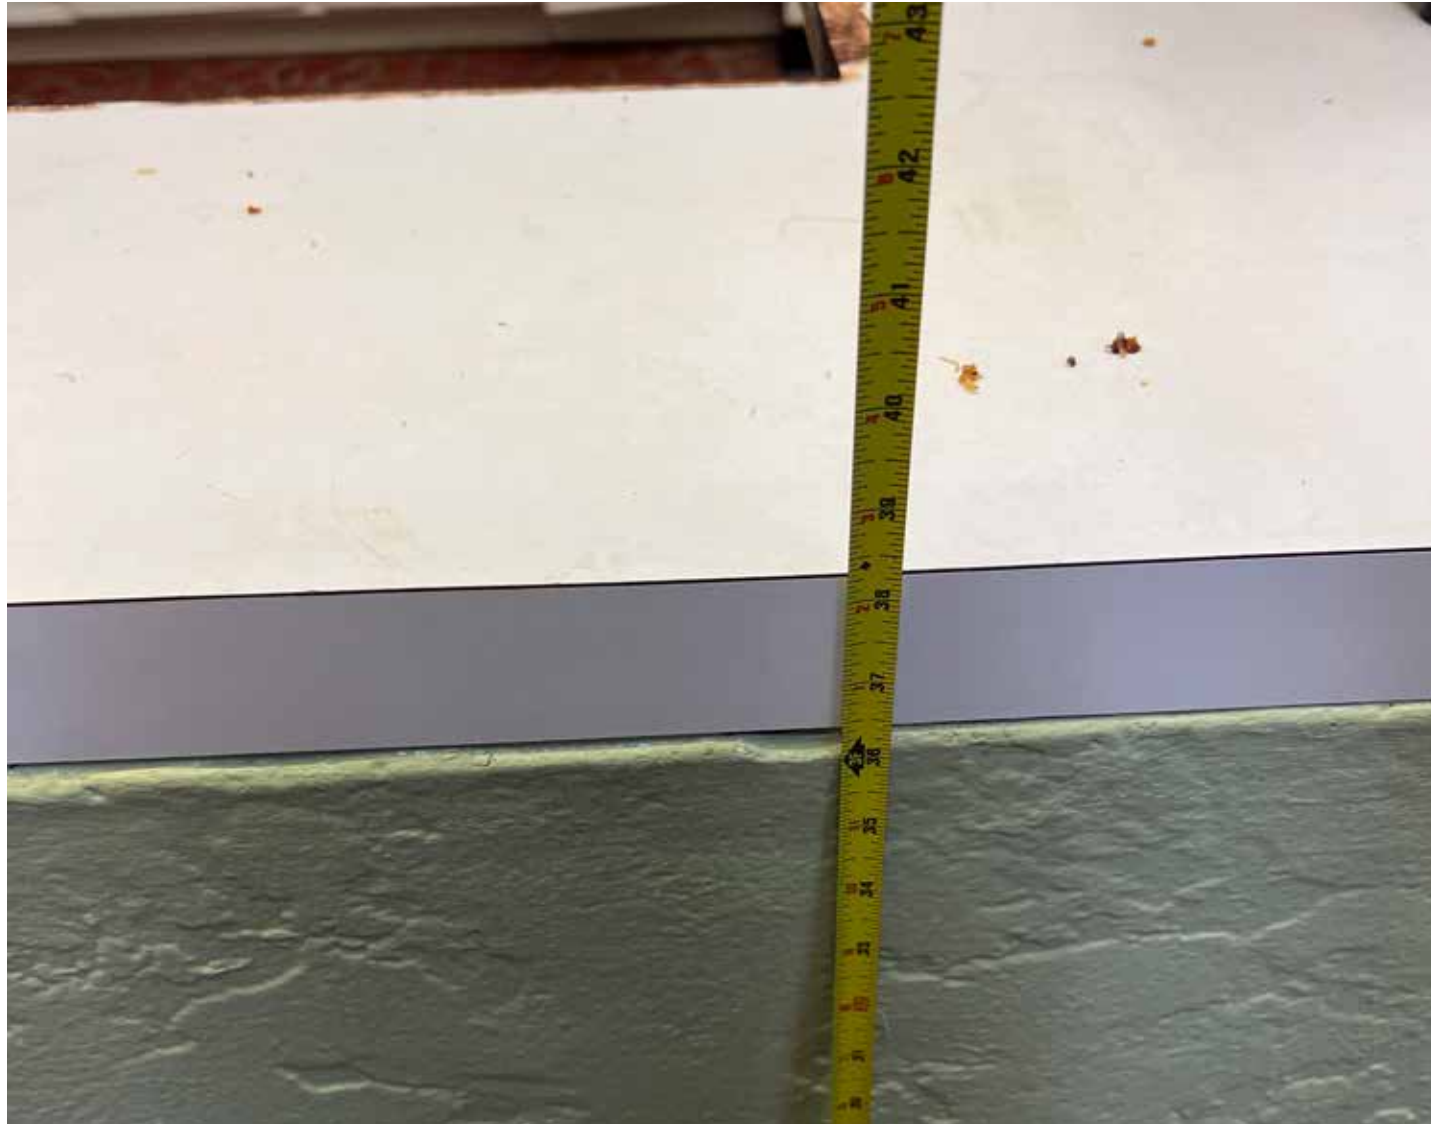
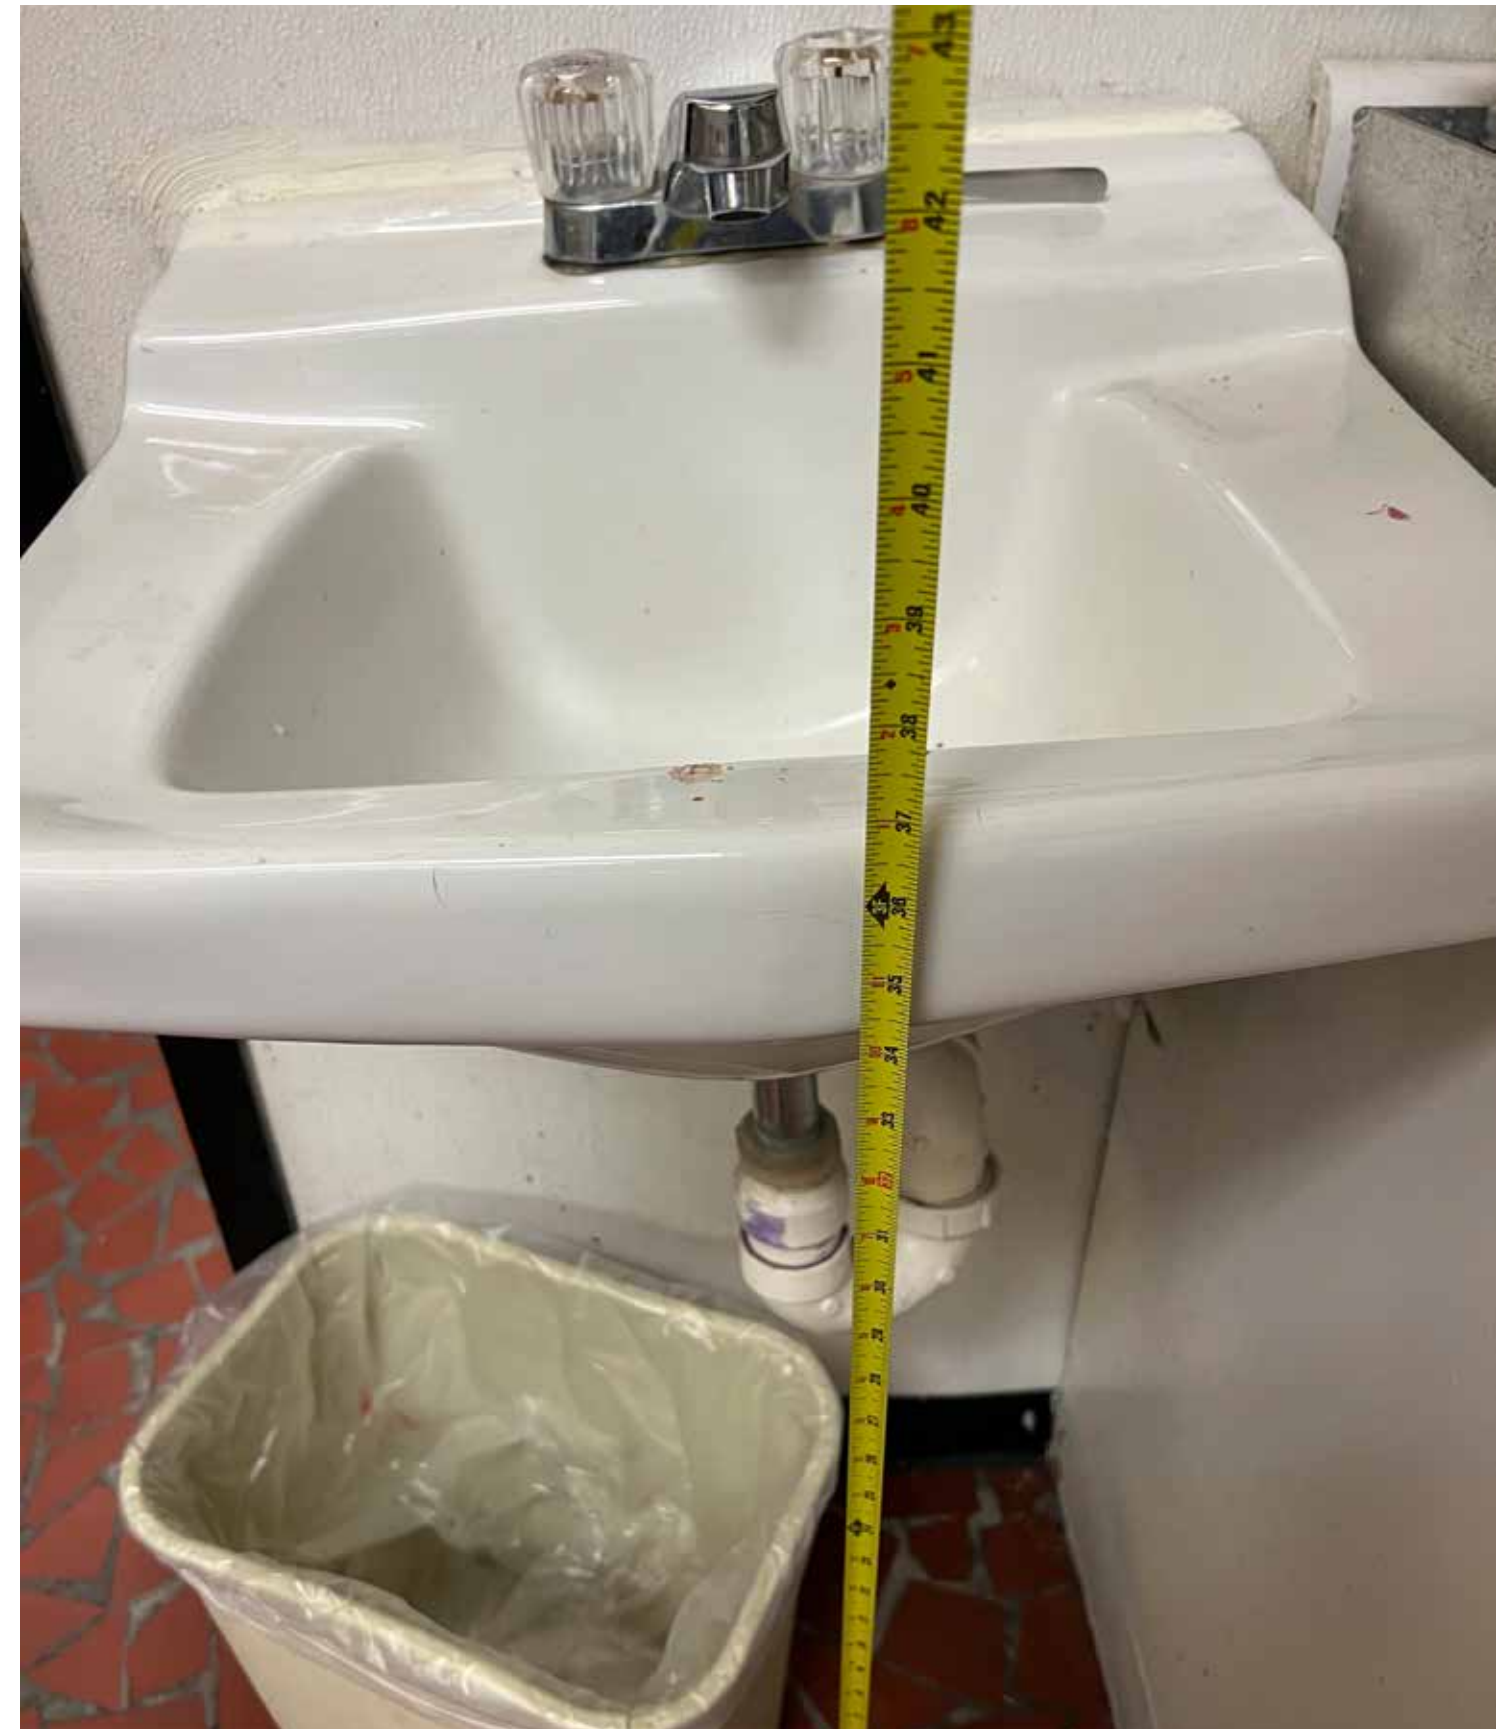
- Service counter height exceeds the maximum height, will need to be lowered to no higher than 36". [2017 ICC A117.1 - Section 904]
- The kitchen hand wash sink exceeds the required 34" height maximum and does not have the proper insulation to protect against leg contact. [2017 ICC A117.1 - Section 606]
- The kitchen hand wash sink also requires 15" clear from the center of the fixture. The adjacent cabinet will require to be shifted. [2017 ICC A117.1 - Section 306]
- The kitchen hand wash sink requires a faucet fixture with levers rather than turn knobs. [2017 ICC A117.1 - Section 309]

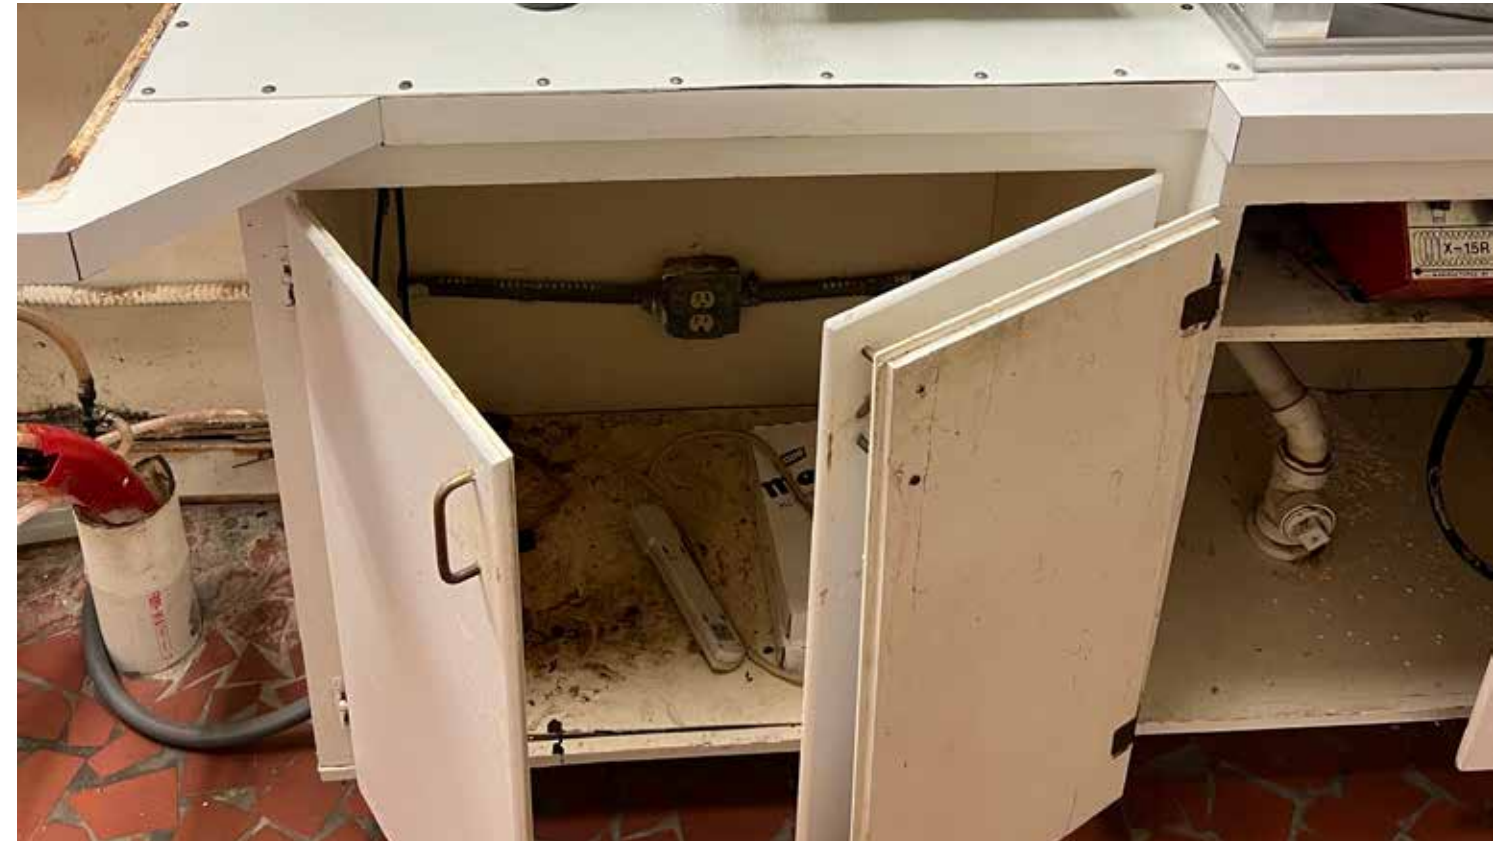
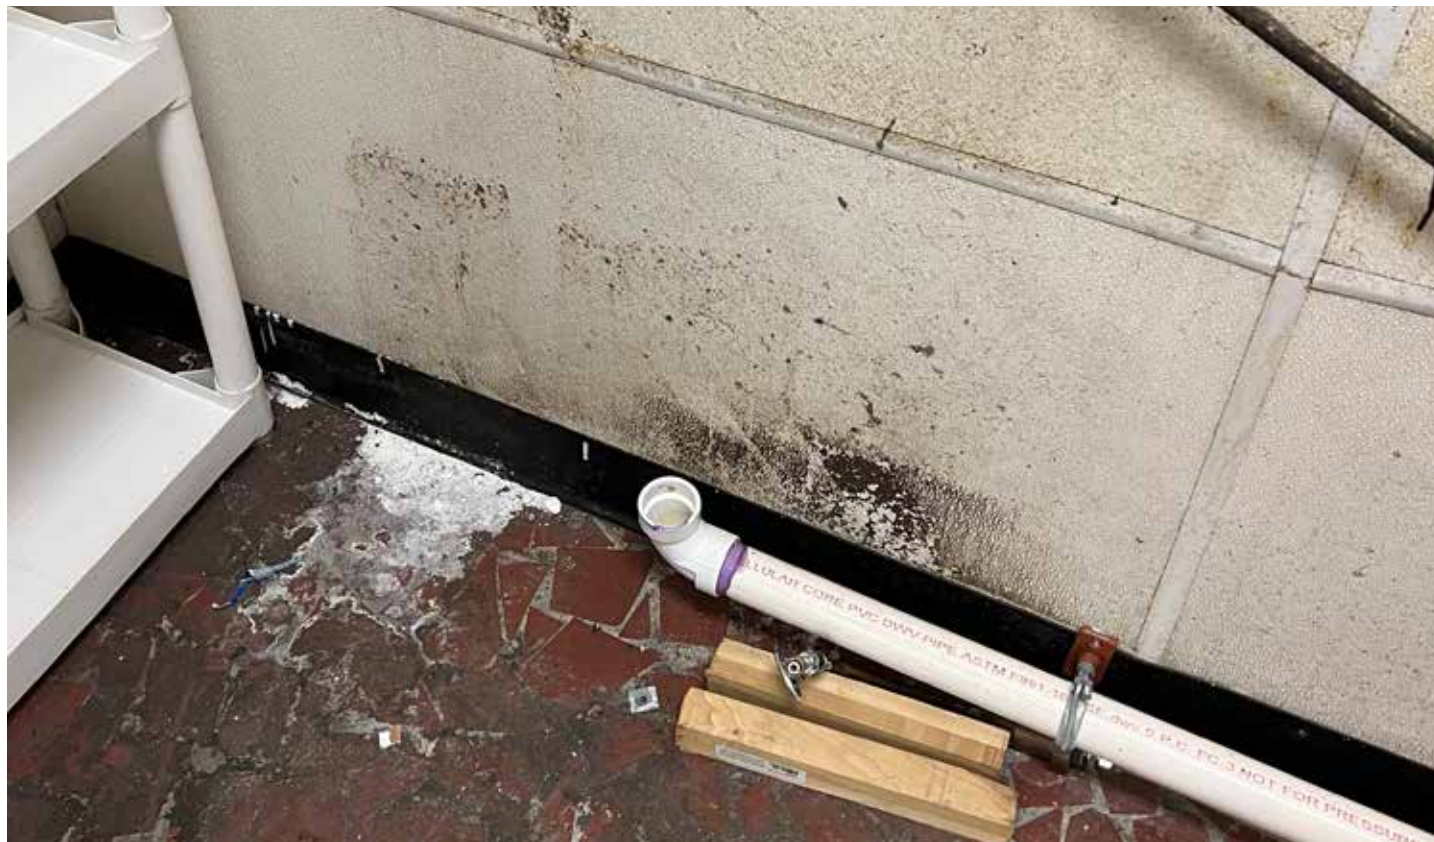
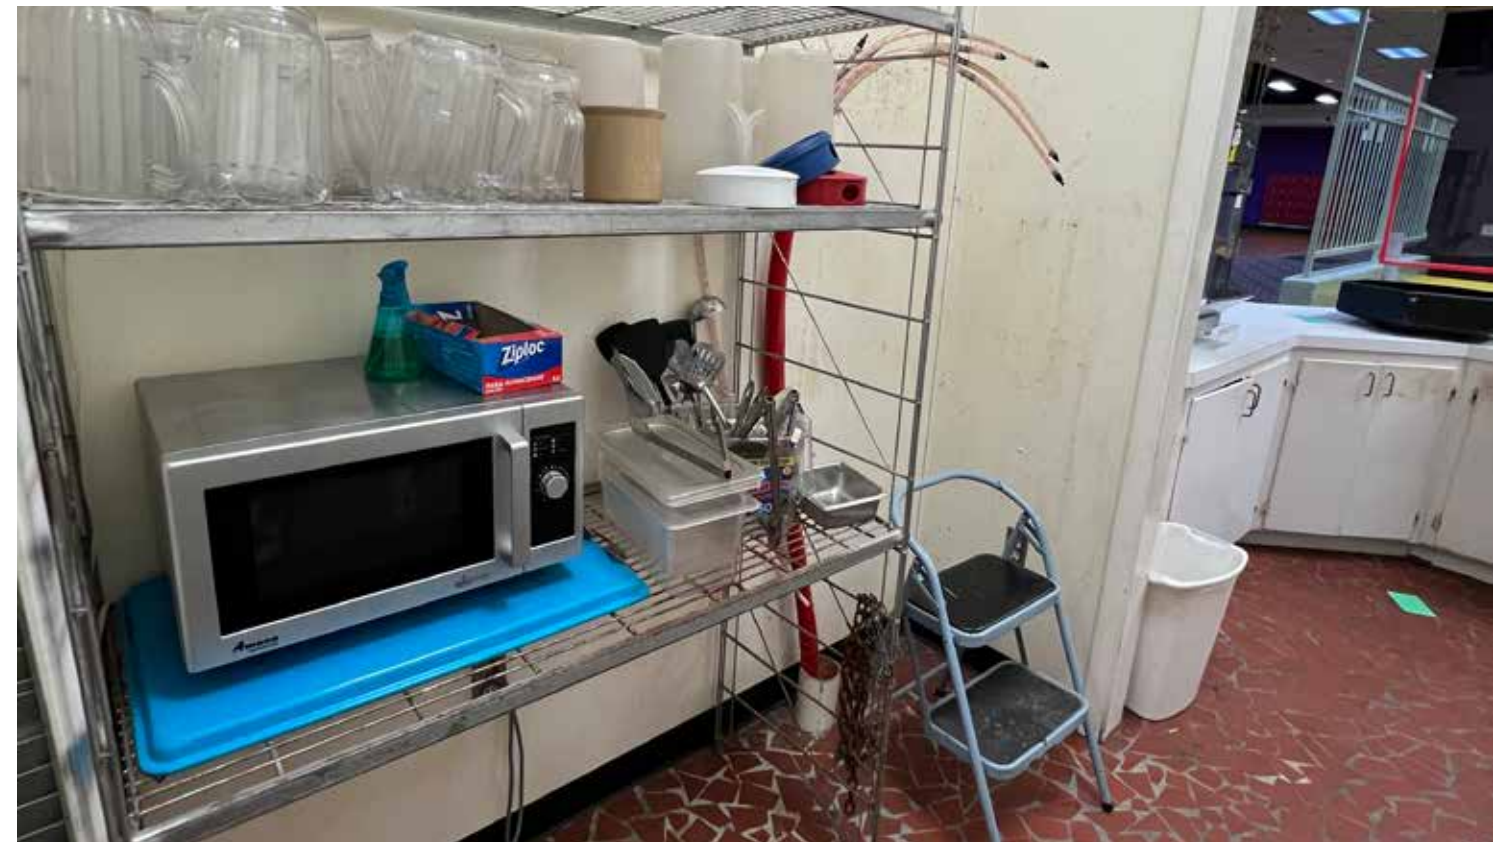
- Prior to opening, the kitchen will need cleaning and renovation preceding approval from the proper Health Department officials.
- Door hardware on each of the two doors in the kitchen area will need to be replaced from knobs to levers. [2017 ICC A117.1 - Section 309]

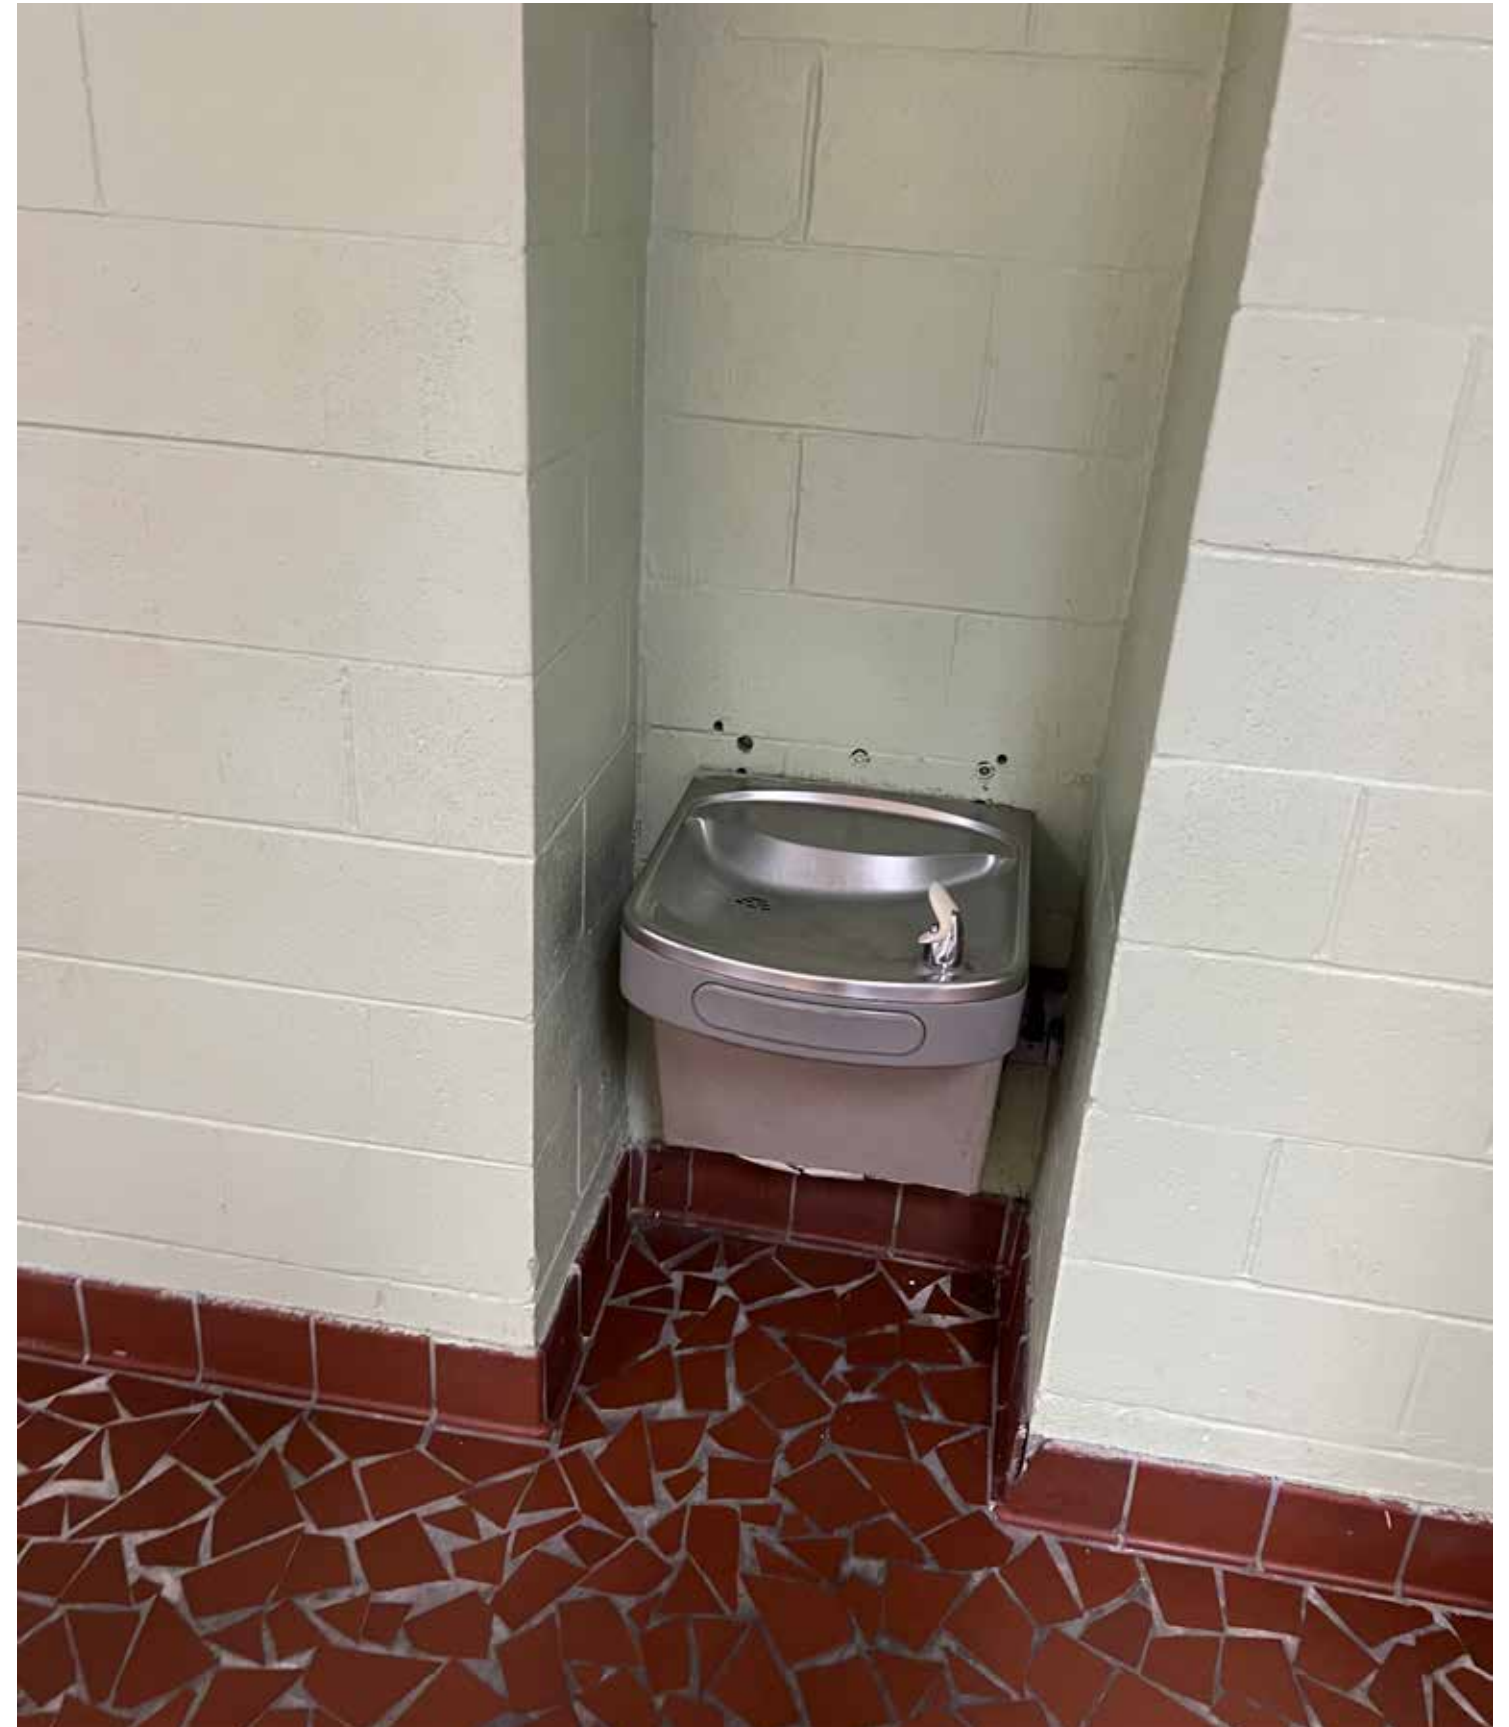
- Water Cooler does not meet accessibility requirements. The required floor space in the alcove is 36" wide. This will need to be relocated and add another water cooler. [2017 ICC A117.1 - Section 305]

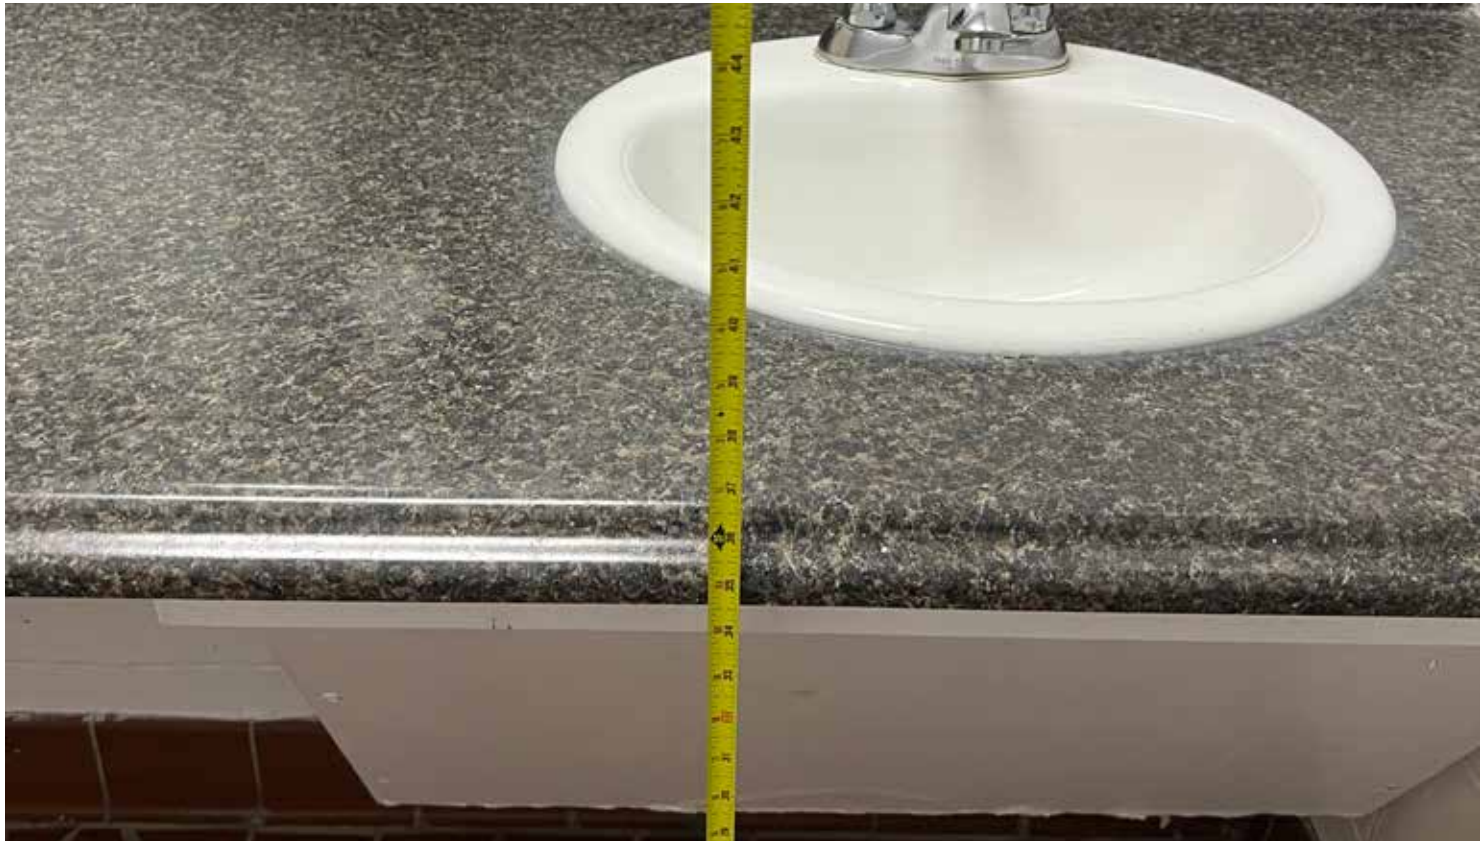
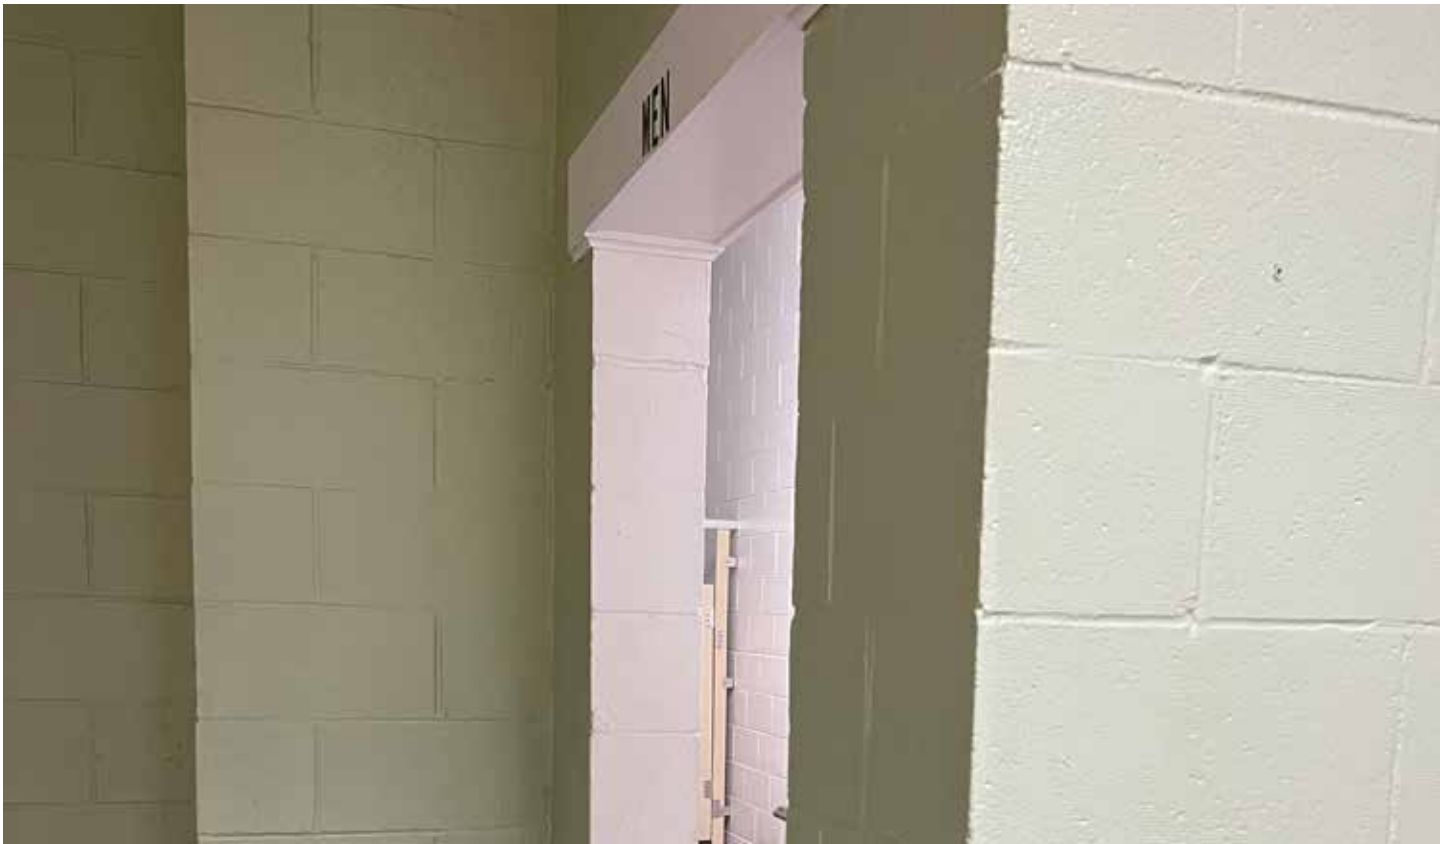
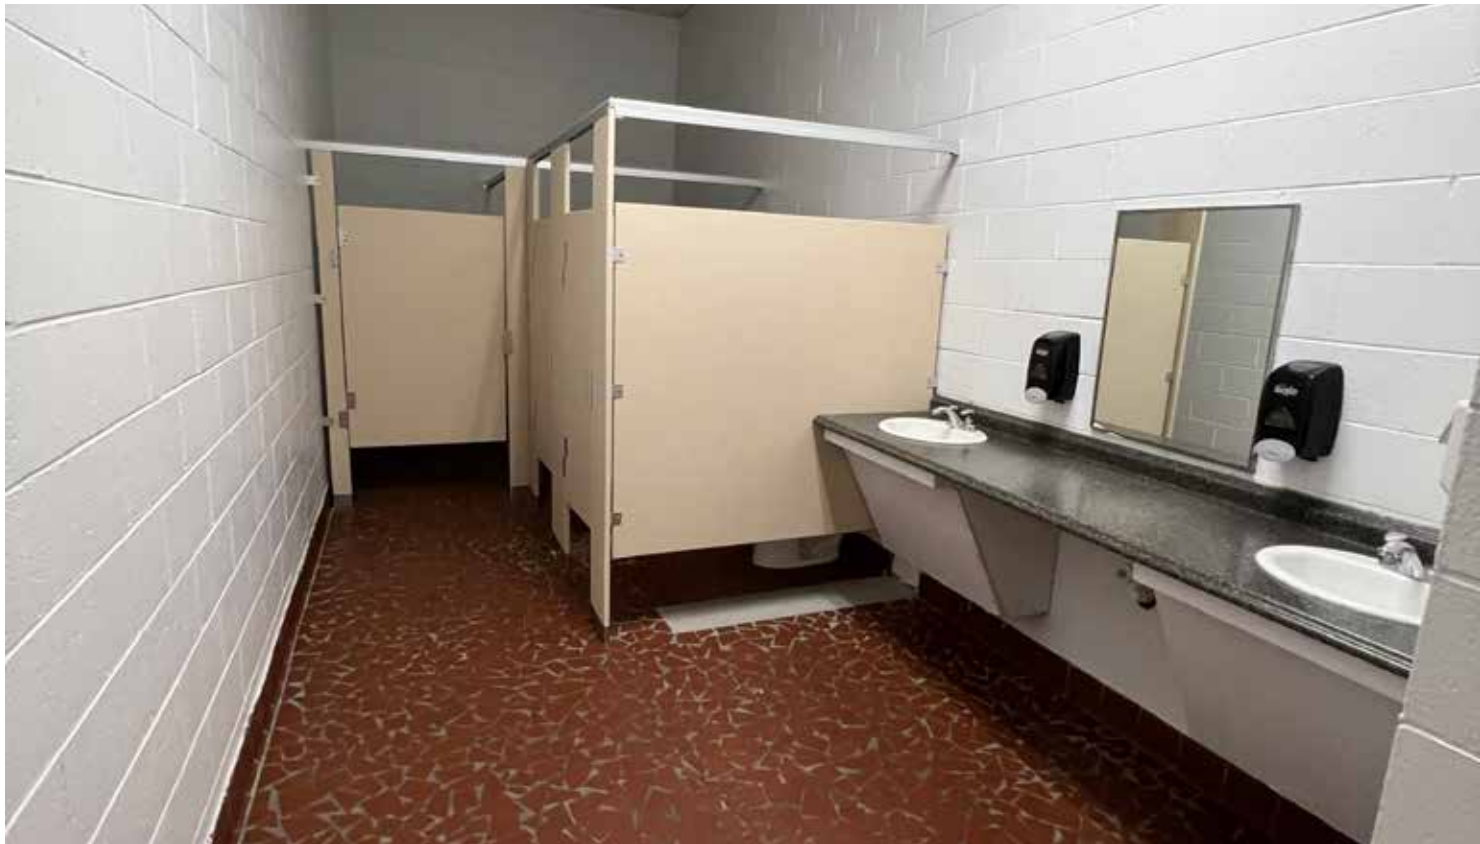
- Lavatory height in both mens and womens restrooms exceed the accessible height. Will need to be lowered at or below 34".
[2017 ICC A117.1 - Section 606]
- There is no way-finding signage for those with sight-limiting disabilities. [2017 ICC A117.1 - Section 703]
