CITY OF DURHAM + DURHAM OUTDOOR AQUATICS STUDY

WHEELS FUN PARK RINK - CODE ANALYSIS

AUGUST 19, 2022

Wheels Recreation Center

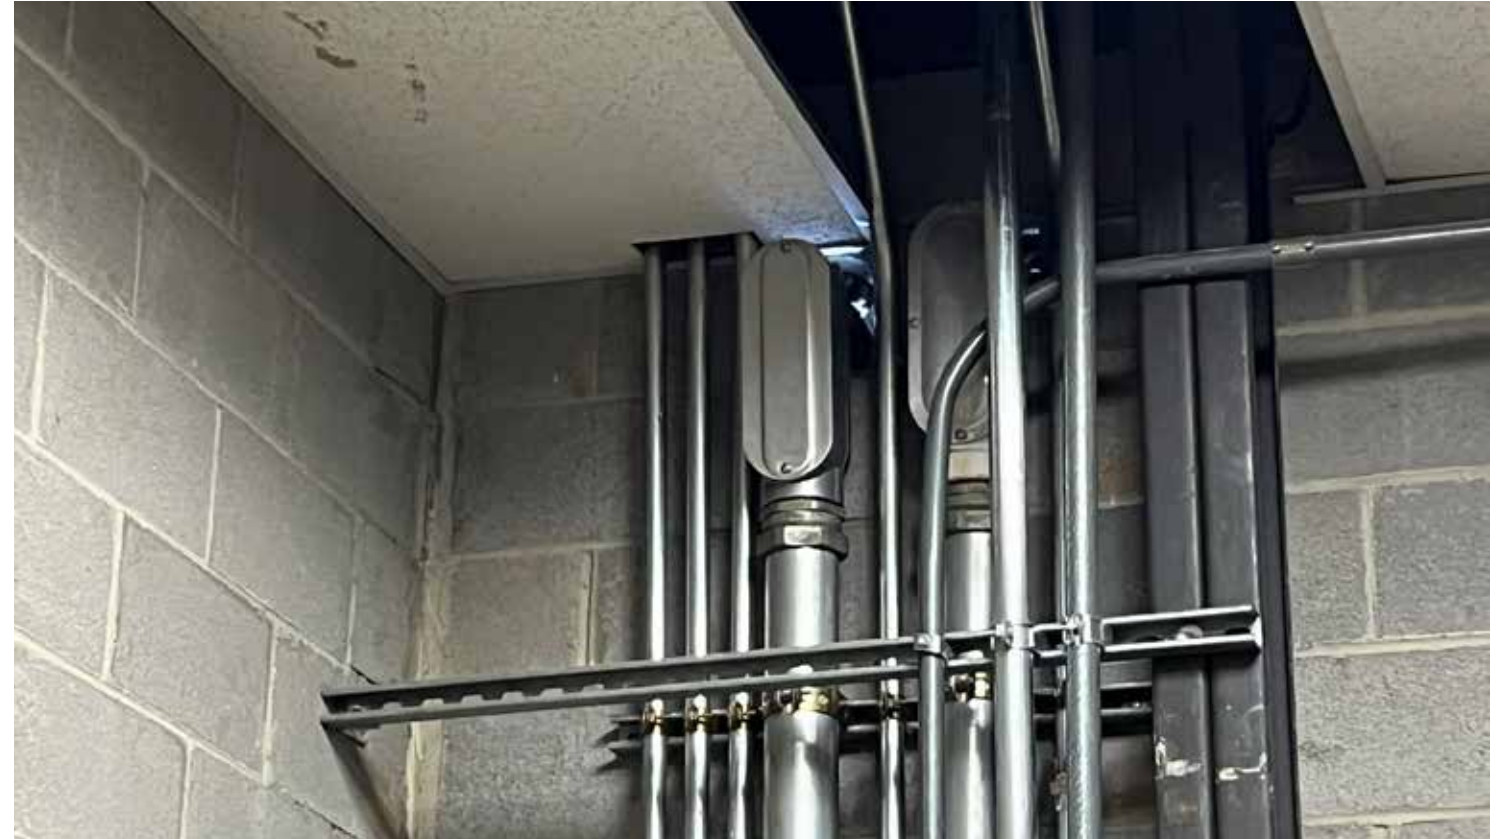
- While there are no accessibility issues regarding the electrical room, there is a concern with the building seal at the electrical conduit.

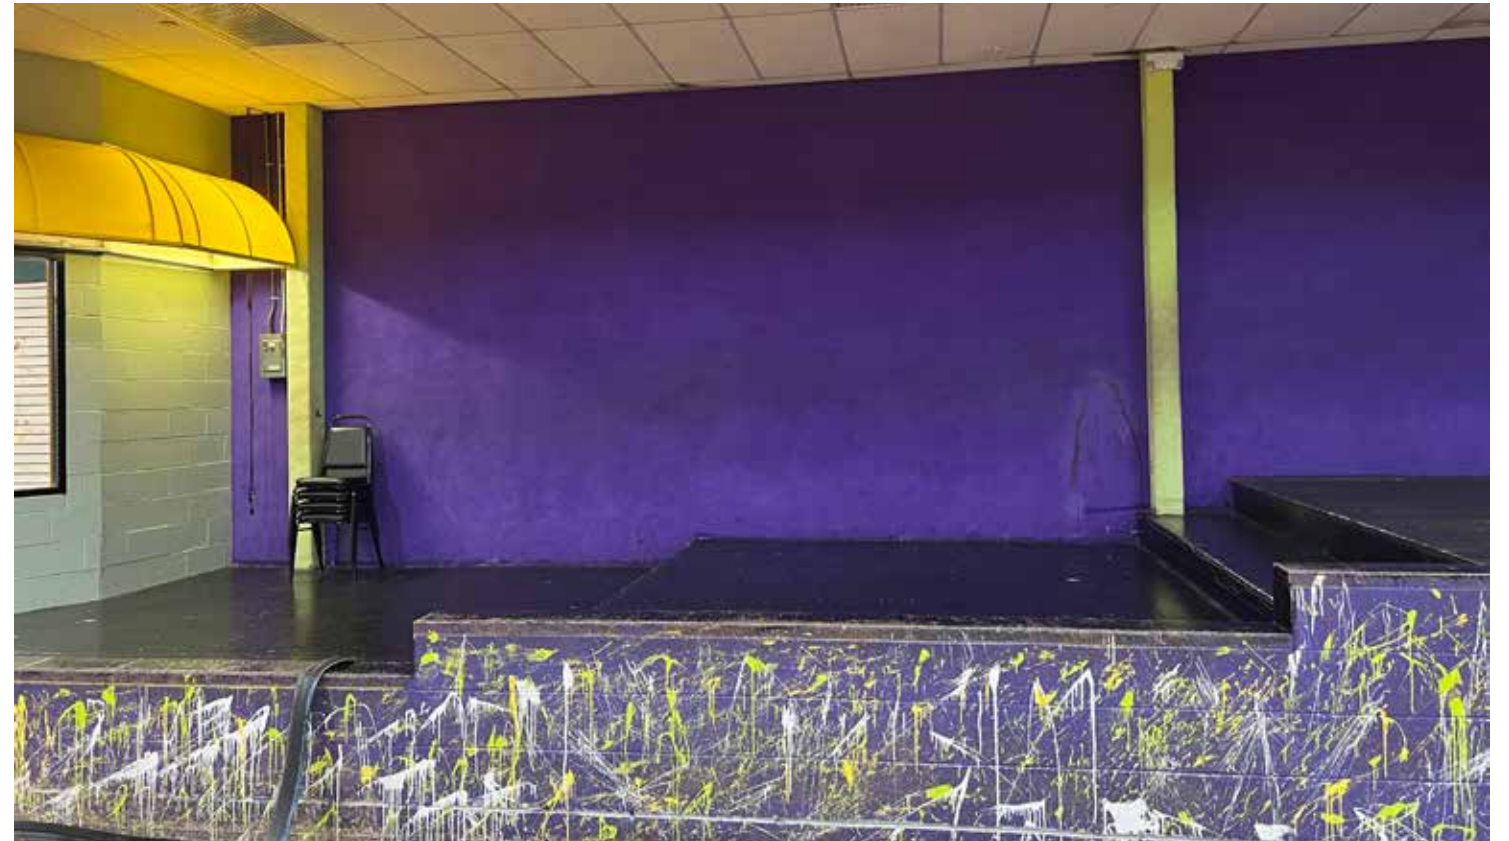
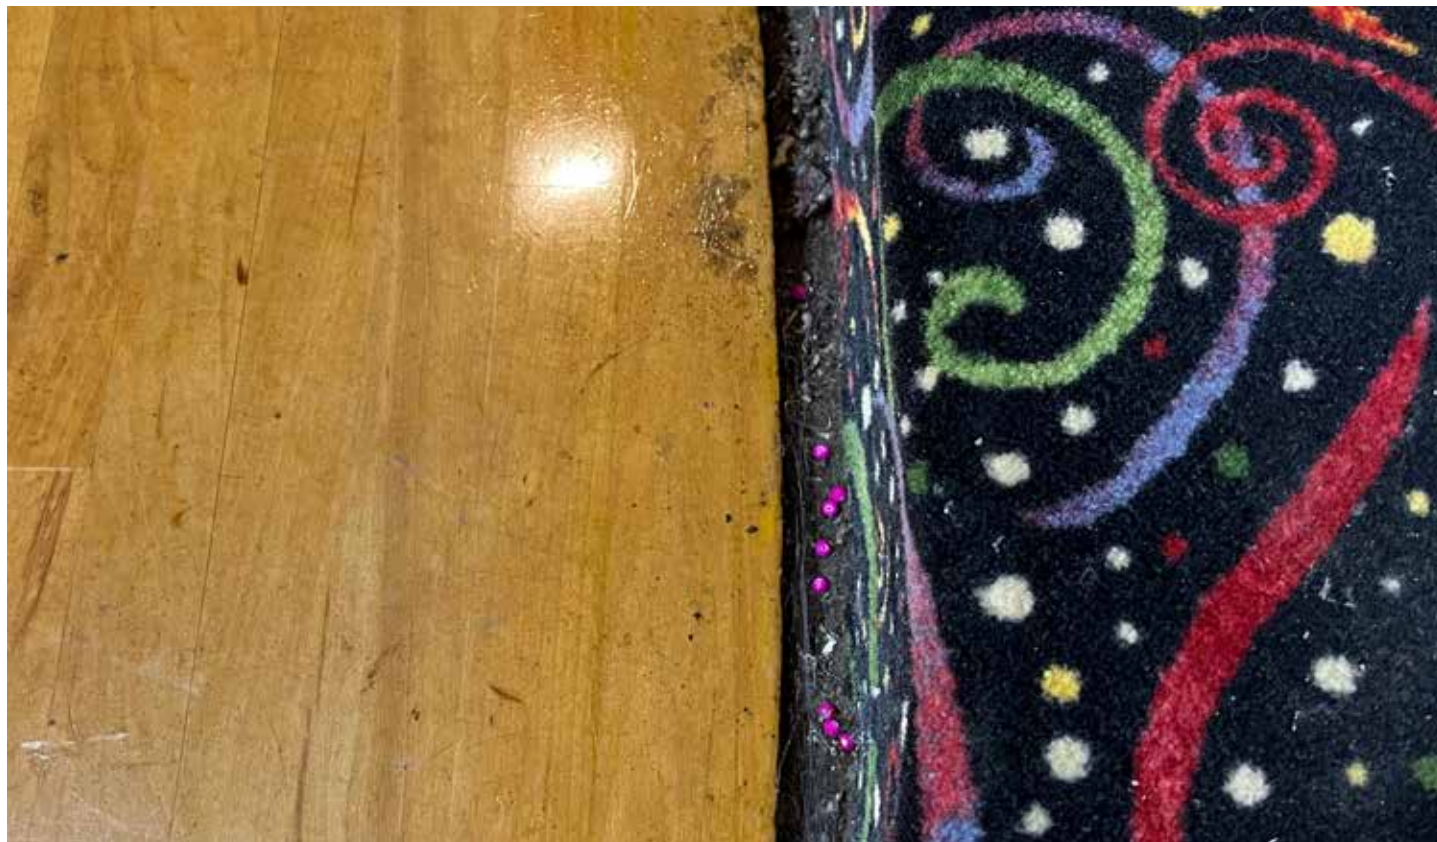
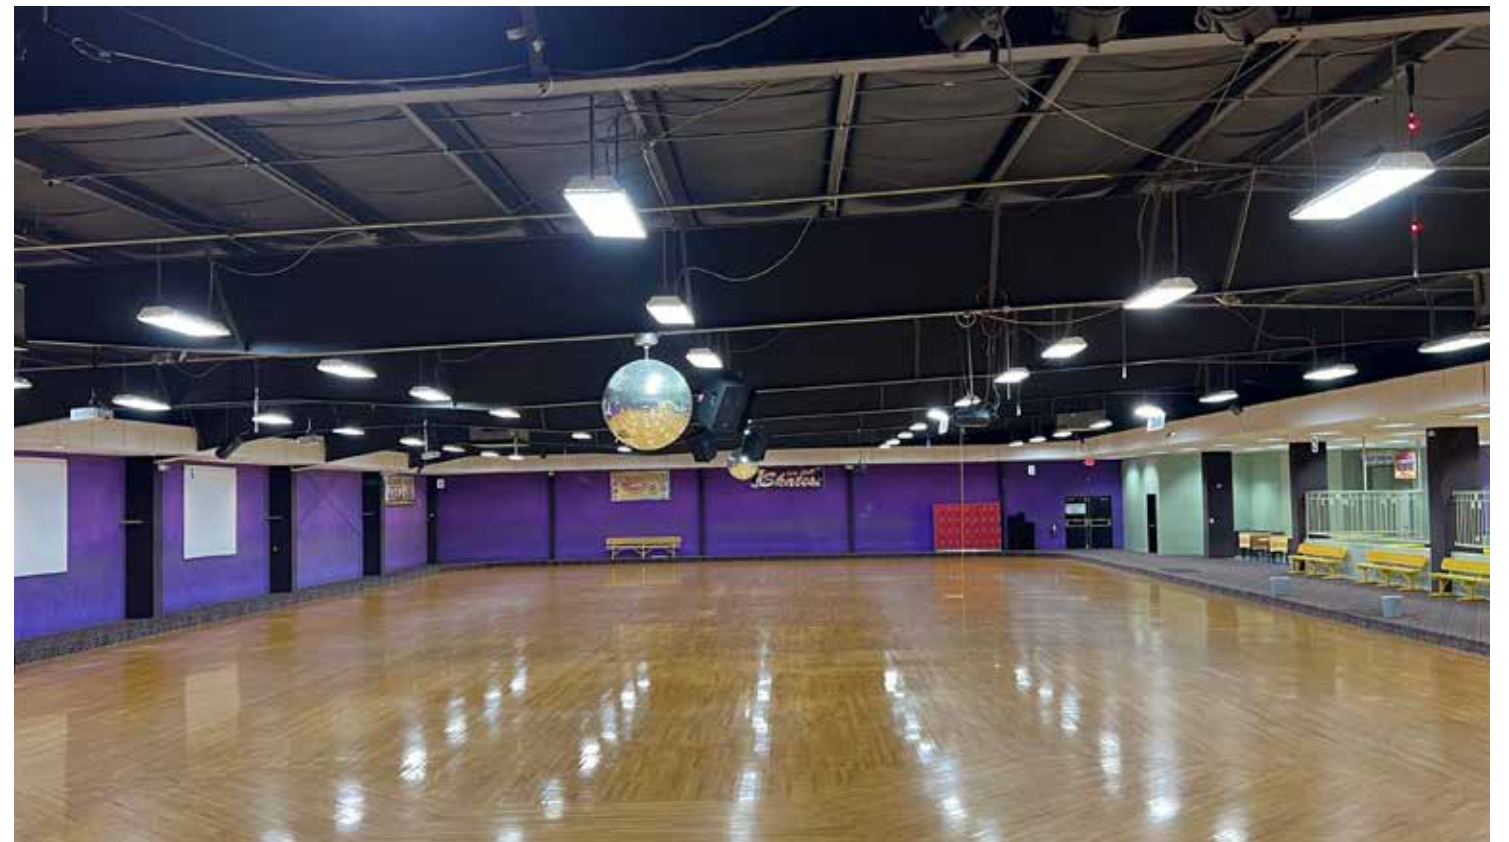
- Stage obstructs accessible route of egress to the north door.
[2017 ICC A117.1 - Section 402]
- There is no accessible route from the walkway to the rink floor. Solution to add proper accessibility could be to add a ramp or remove a portion of the raised floor. [2017 ICC A117.1 - Section 402]
- While not an accessibility issue, there is a 1"-2" gap between the rink floor and the edge of the walkway. This could potentially become a hazard. Add trim to prevent this issue.

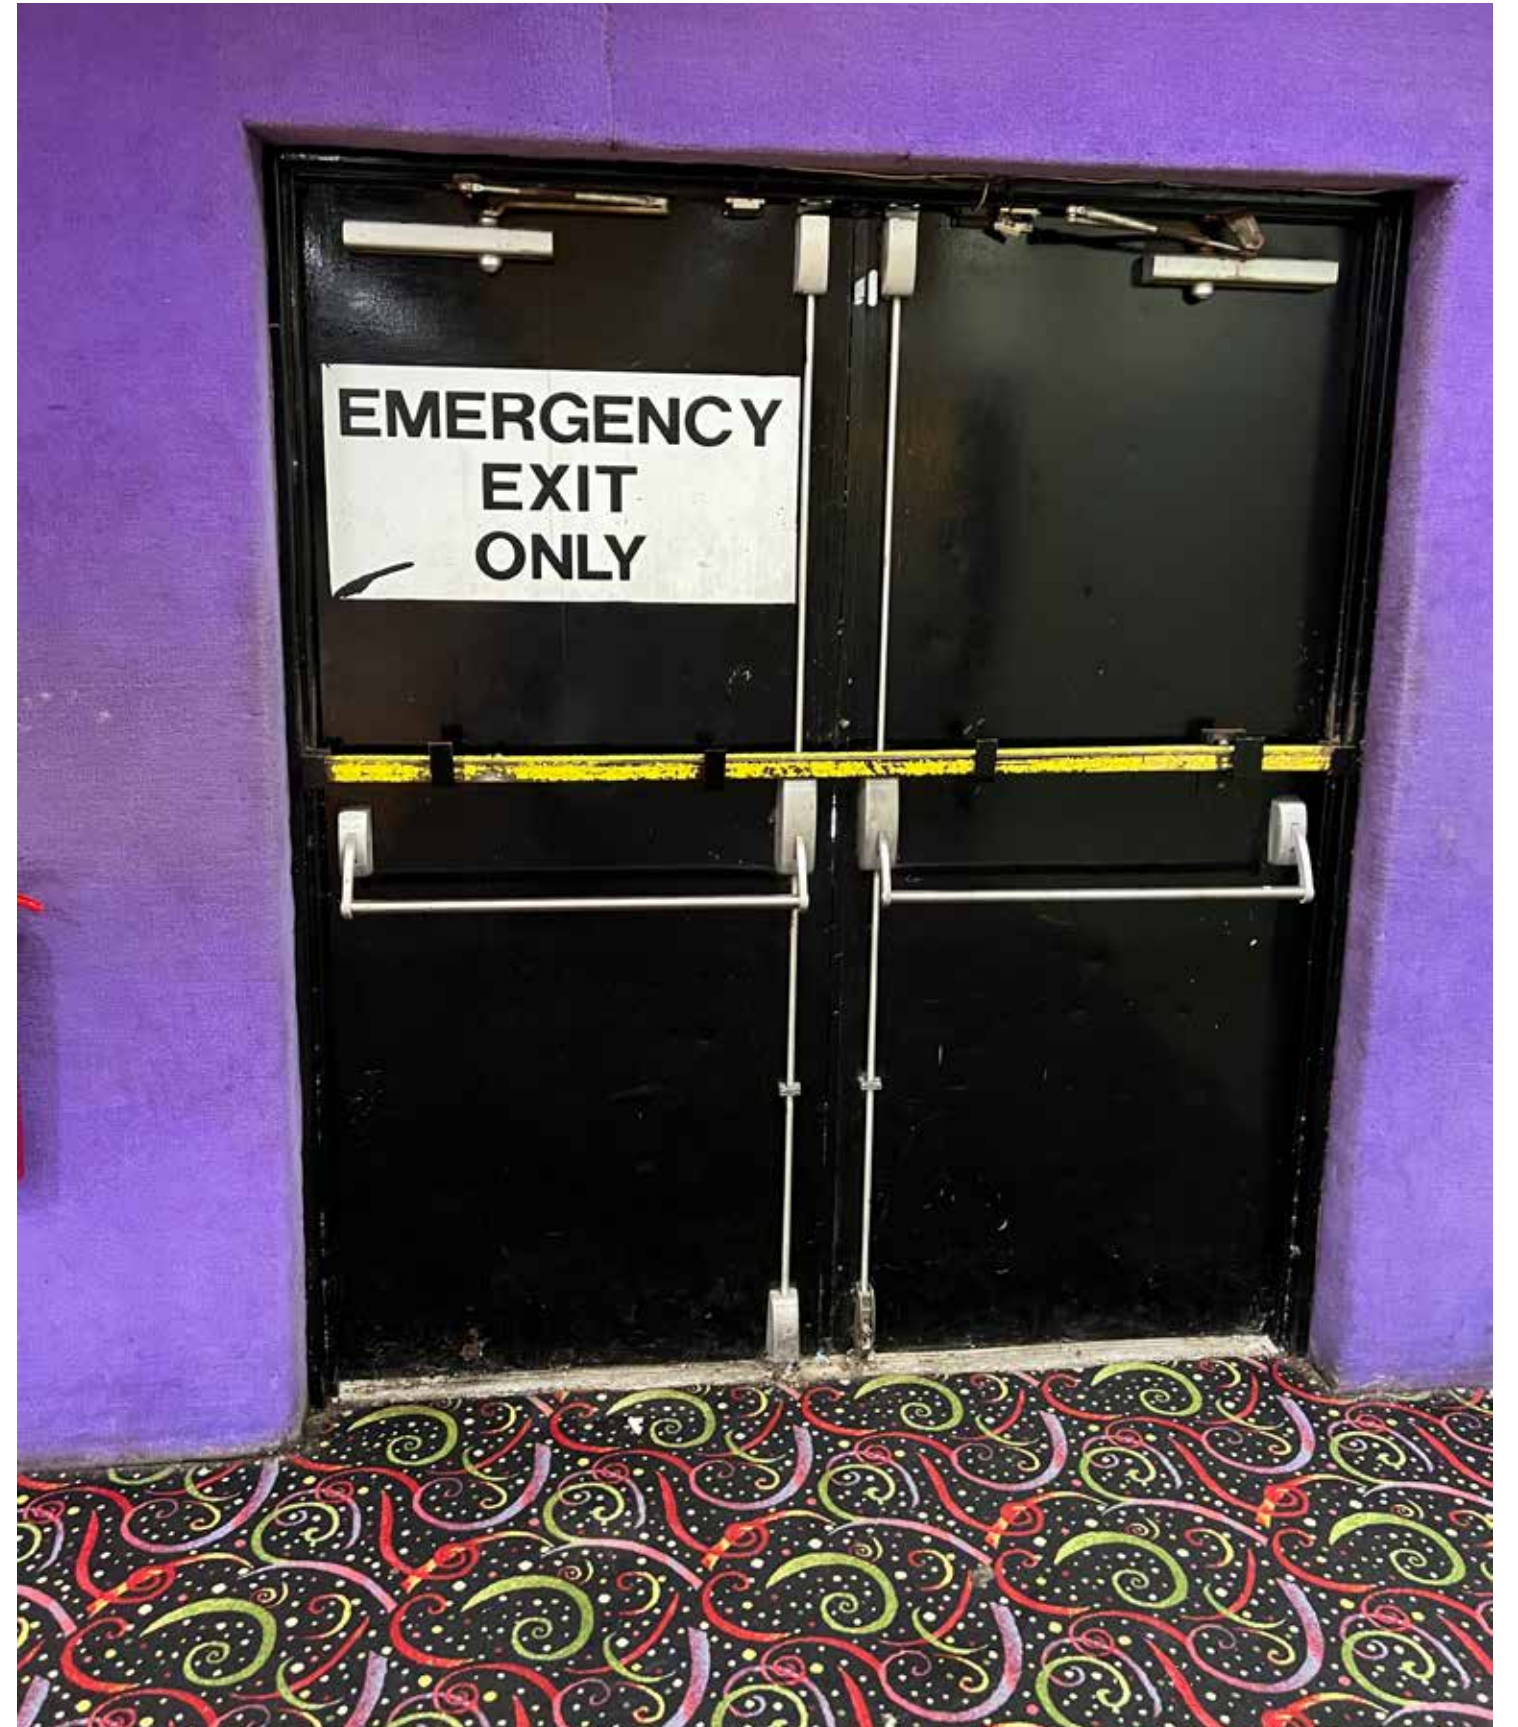
- The security bar used to keep the egress doors shut will need to be removed prior to opening.

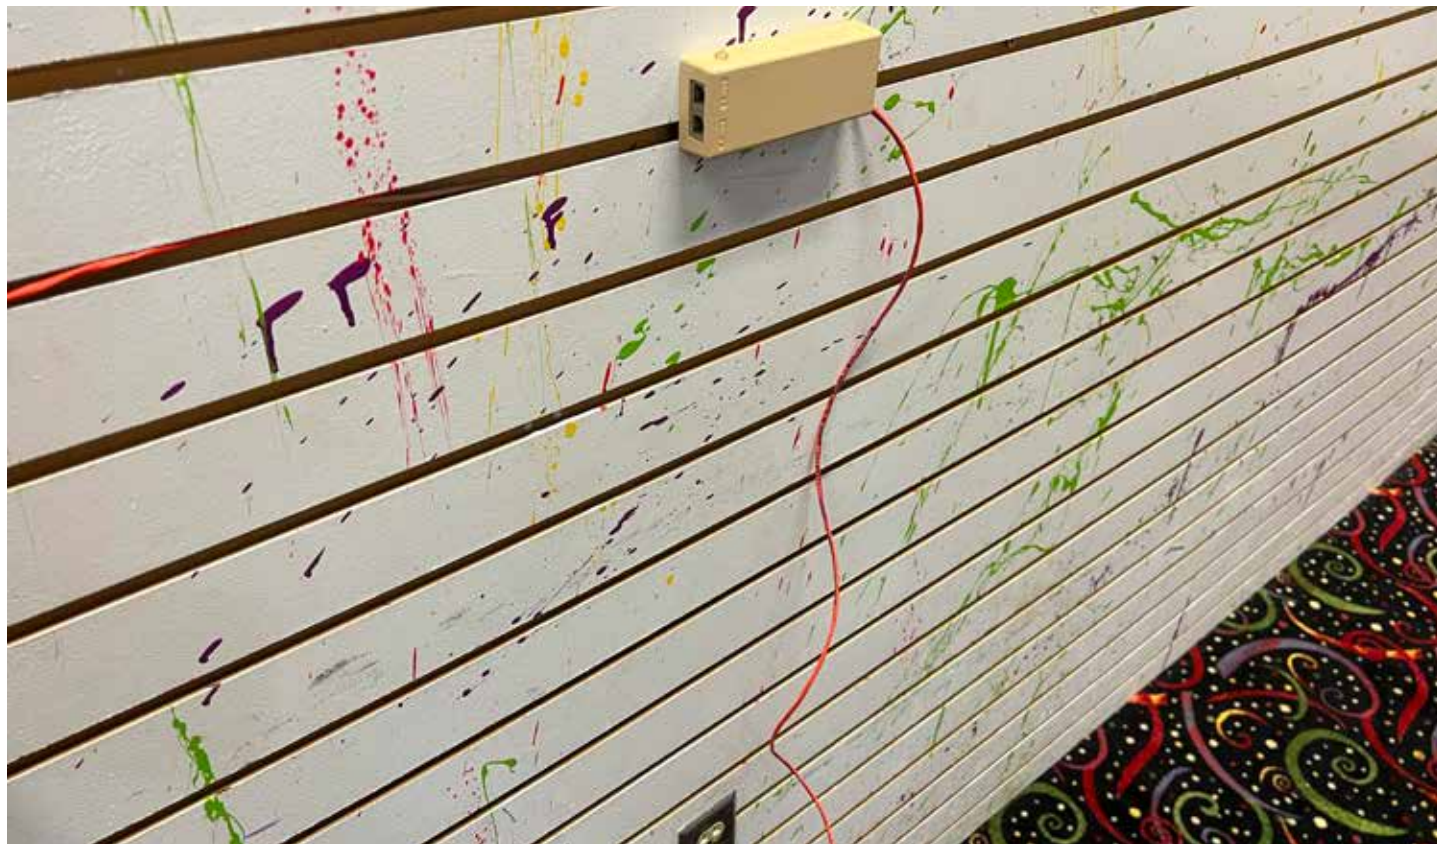
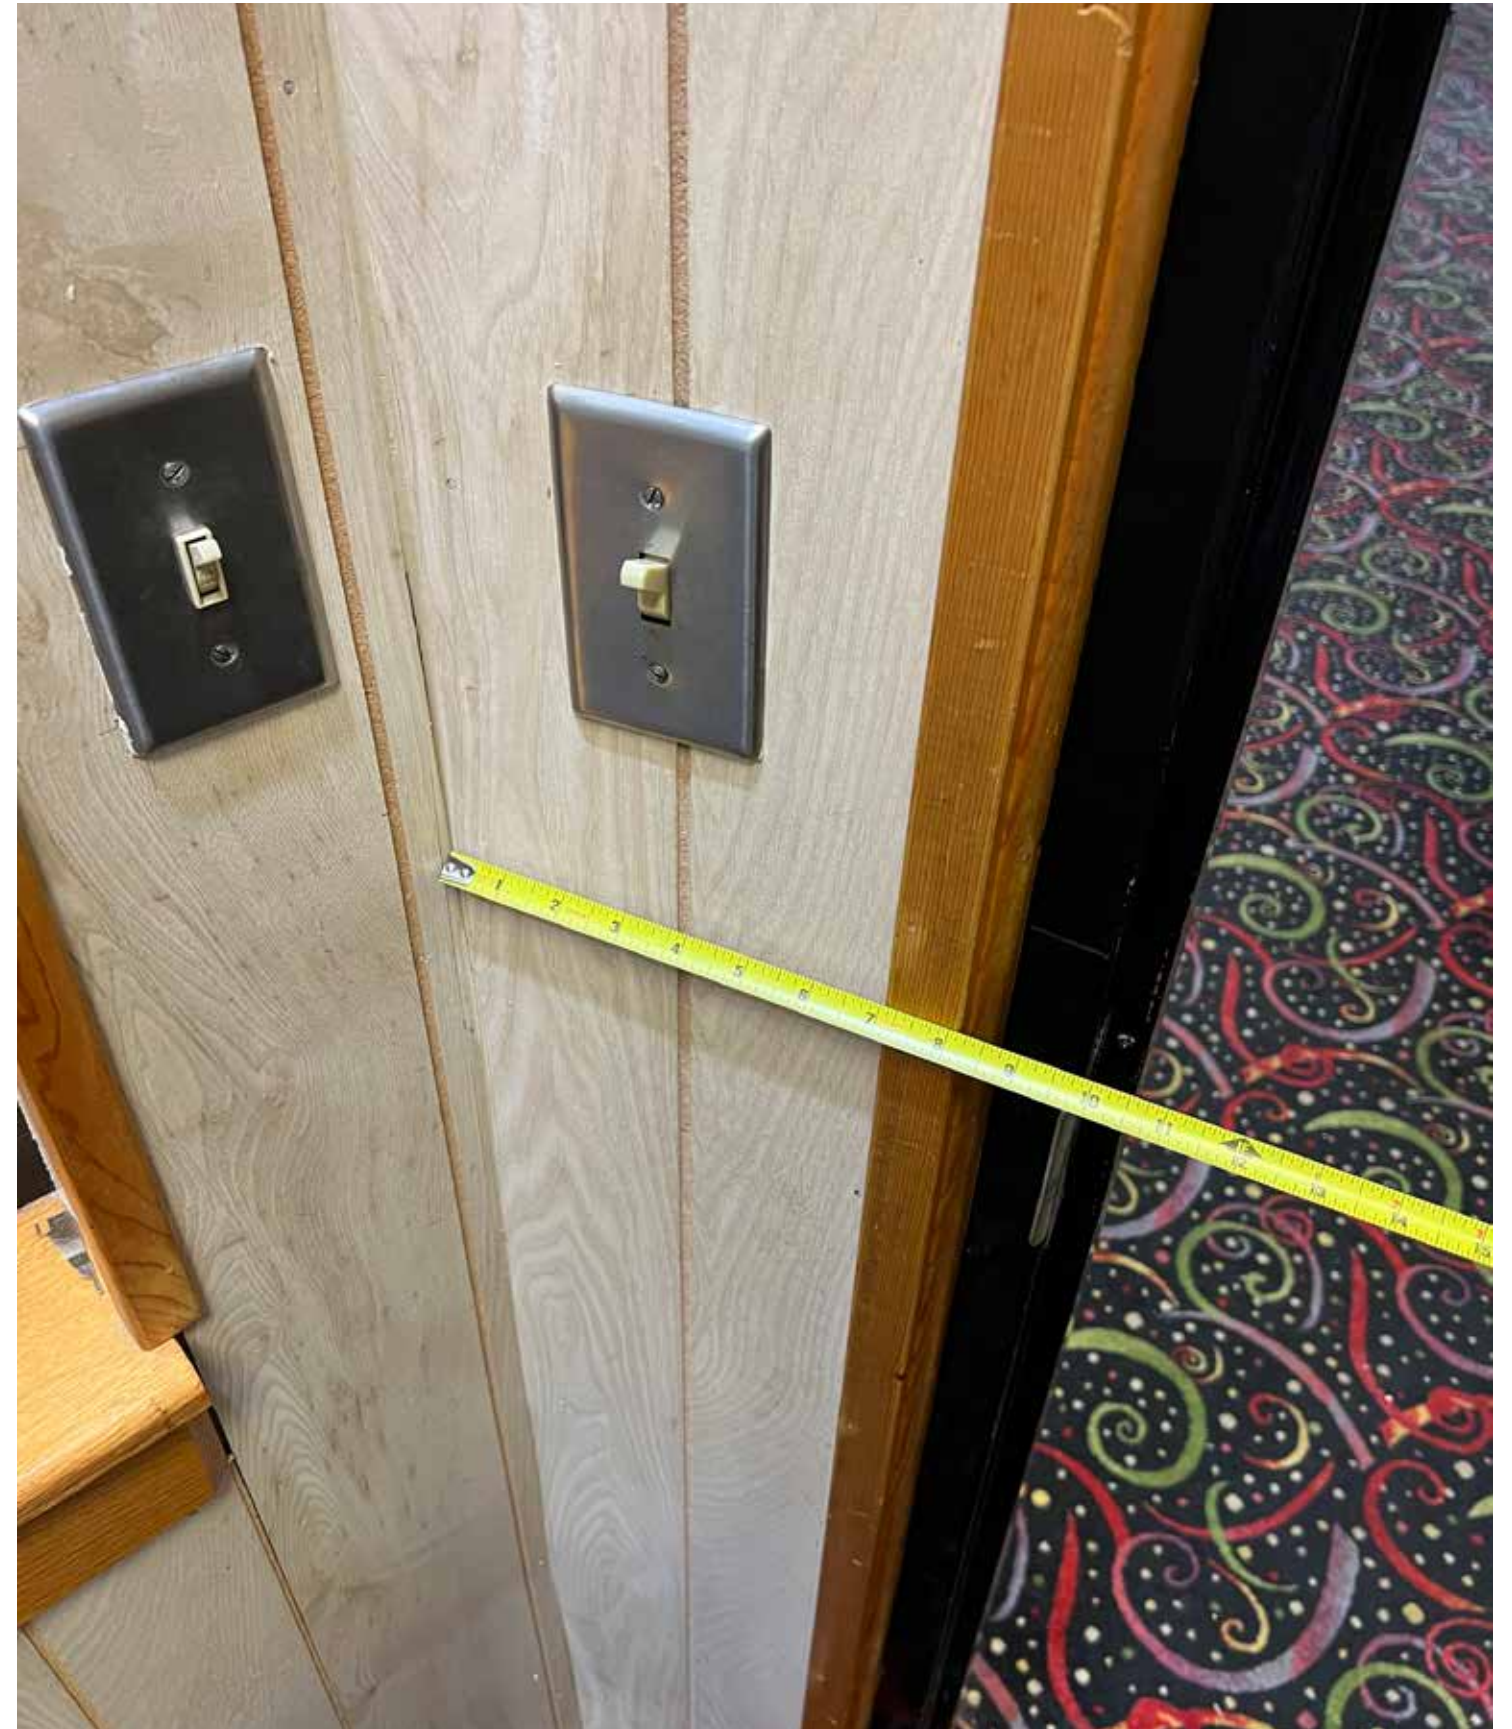
- Accessible pull clearance on the entry door to the party room does not have the proper clearance. [2017 ICC A117.1 - Section 404]
- While not an accessibility issue, loose wire on the wall could be a problem.
- Door hardware on each of the two doors in the party room area will need to be replaced from knobs to levers. [2017 ICC A117.1 - Section 309]

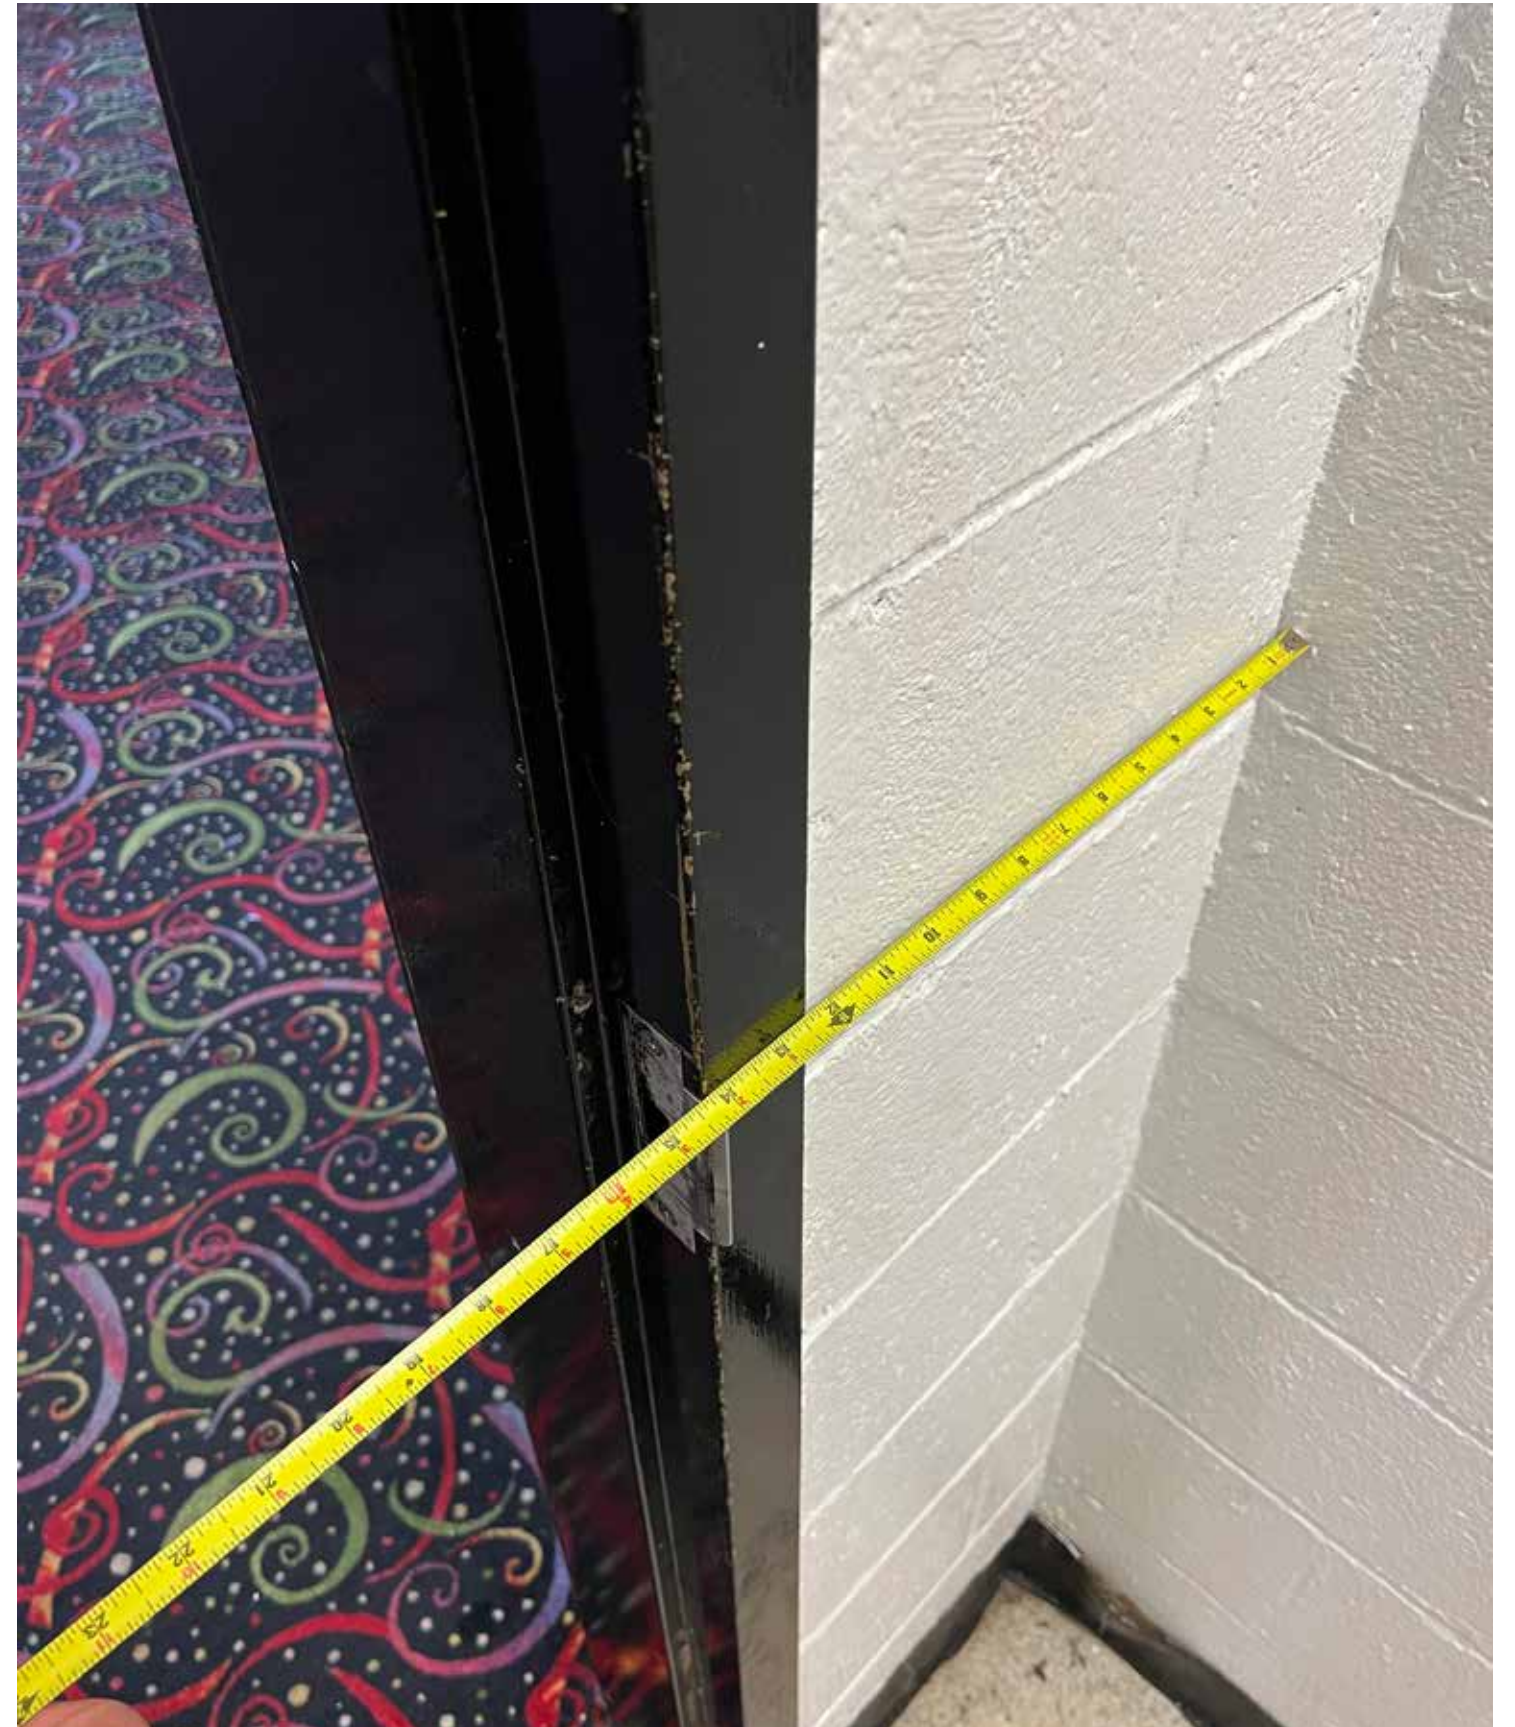
- The pull clearance inside the skate rental door does not meet accessibility standards. Wall will need to be shifted by at least 4". [2017 ICC A117.1 - Section 404]
- Door hardware on the door in the skate rental area will need to be replaced from knobs to levers. [2017 ICC A117.1 - Section 309]

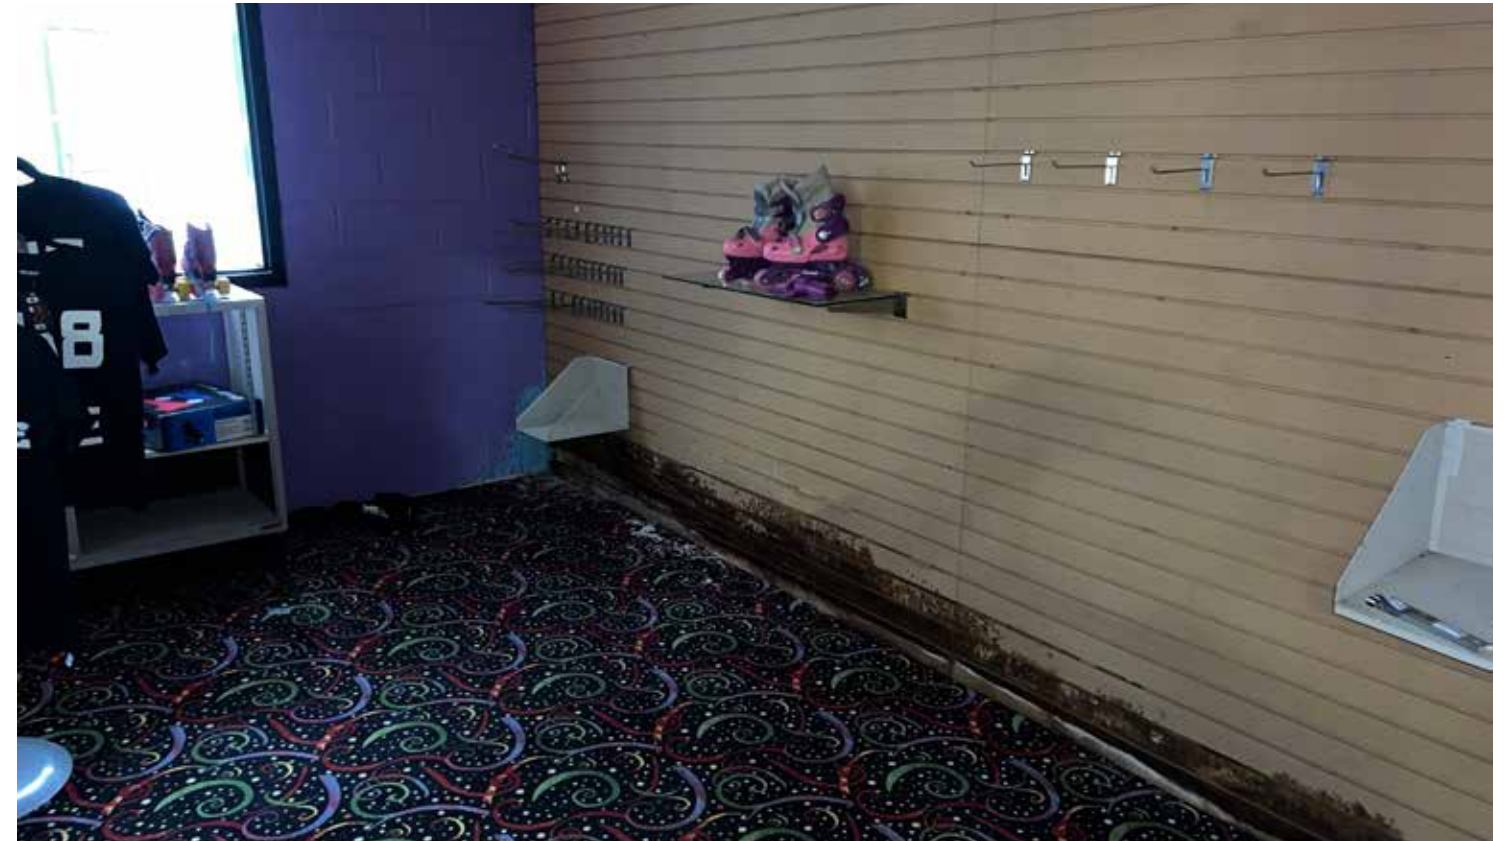
- The lights in the store area do not work.
- The wood siding base at the exterior wall should be investigated for possible mold and water intrusion.
- Door hardware on the door in the store area will need to be replaced from knobs to levers. [2017 ICC A117.1 - Section 309]

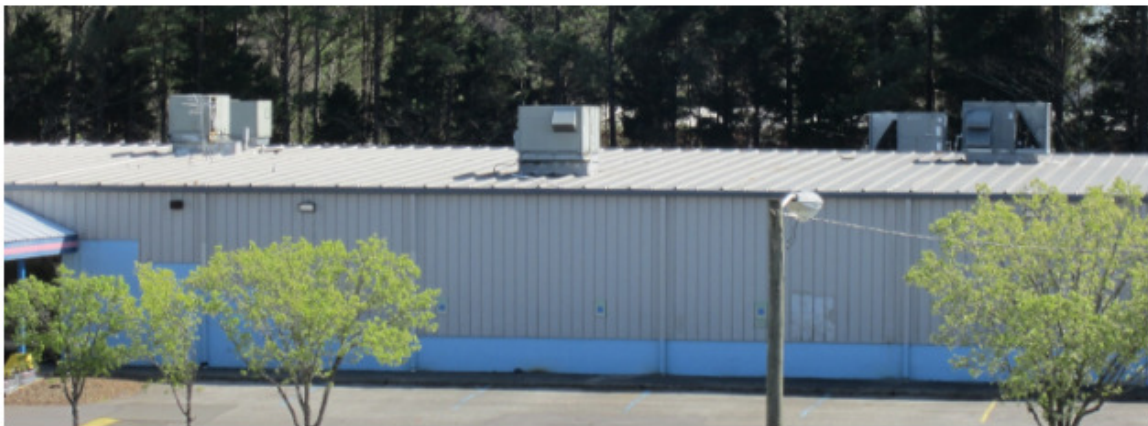
Skate Center RTUs (Photo taken from roof of Play Structure)

1. RTU#1 was iced up at the time of the site visit.
2. RTU#2 does not have heating capability.

- The Trane units (RTU#1 and RTU#5) are in poor condition and have reached their expected useful life.
- Trane unit RTU#2 is 13 years old and nearing the end of its expected useful life.
- The Daikin units (RTU#3 and RTU#4) are 8 years old, in fair condition, and expected to have a remaining useful life of 5 to 10 years with normal maintenance performed on a regular basis.
