CITY OF DURHAM + DURHAM OUTDOOR AQUATICS STUDY

WHEELS FUN PARK RINK - CODE ANALYSIS

AUGUST 19, 2022

Wheels Recreation Center

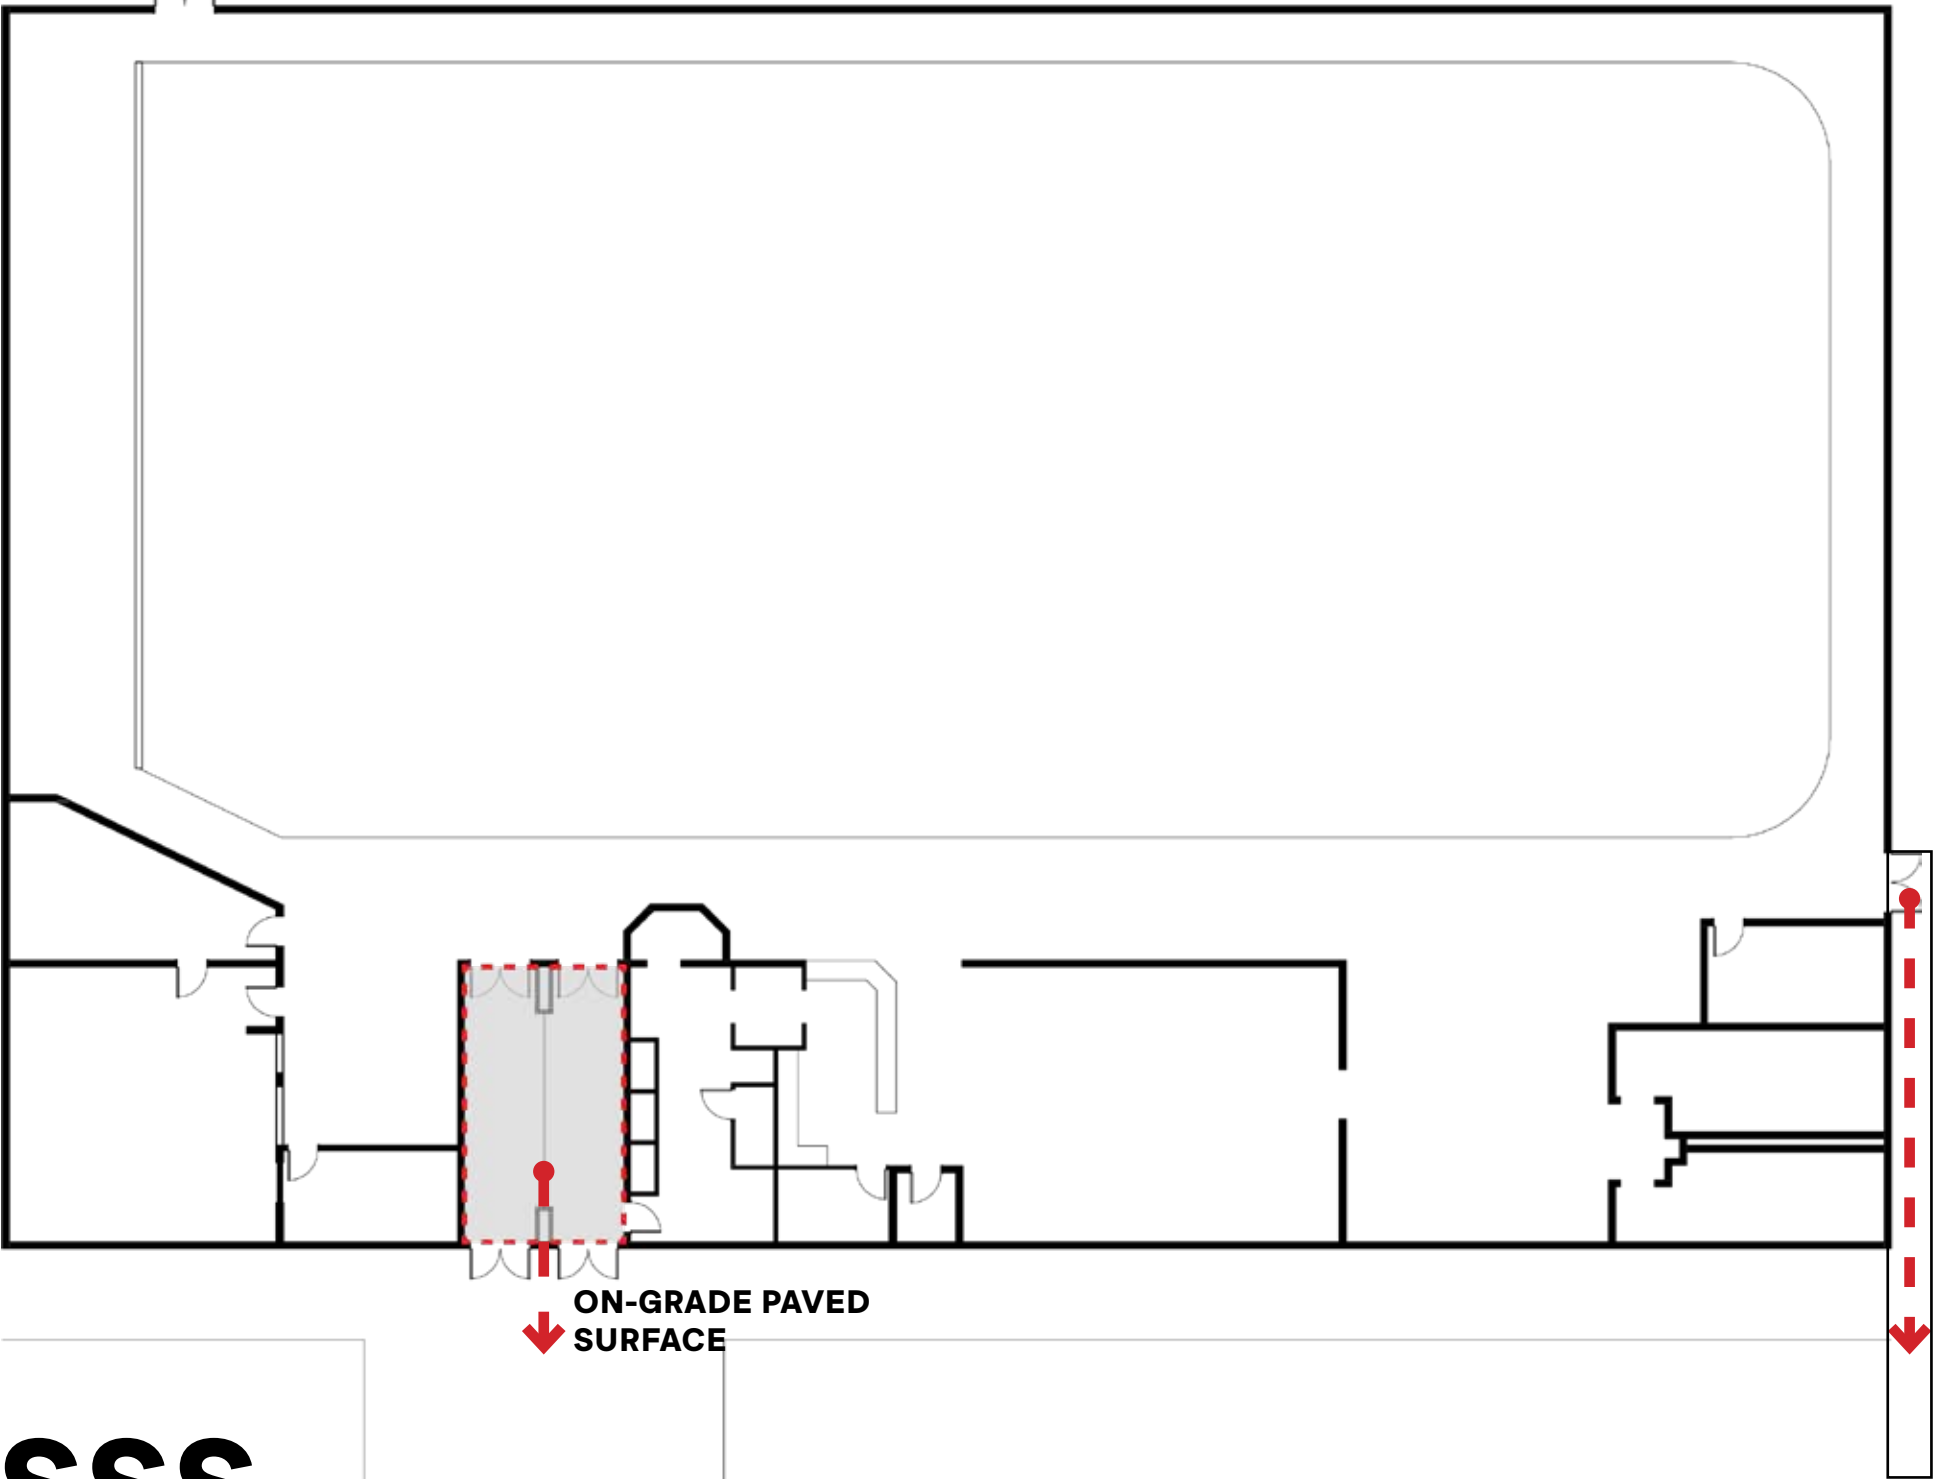
ENTRY/EGRESS

- The parking lot does not have curb ramps for accessibility. Parking area curb ramps will need to be constructed to provide accessible parking. [2017 ICC A117.1 - Section 406]
- Provide access aisle for van parking that can be shared between two accessible parking spaces. [2017 ICC A117.1 - Section 502]
- Optional: affix the entry and exit doors with automatic door opening hardware. [2017 ICC A117.1 - Section 404]

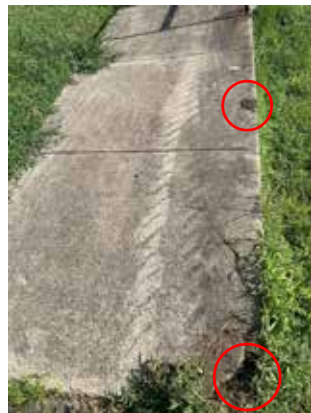
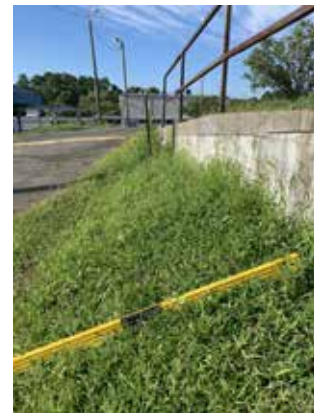
WHEELS FUN EXISTING ACCESS RAMP

- Surface slopes along existing ramp are acceptable but bottom of ramp does not meet an ADA compliant route. Ramp would need to be reconfigured to turn around northwest corner of building to meet an accessible grade.
- Existing single handrail does not meet current ADA requirements. Handrail to be removed & replaced with ADA compliant handrails on both sides of ramp.
- One area along the ramp has >30" fall height. Fill would need to be added to decrease fall height or new pedestrian guardrail would need to be added for the top landing

NEW COMPLIANT
HANDRAIL NEEDED ON
BOTH SIDES OF RUNS
>5% SLOPE

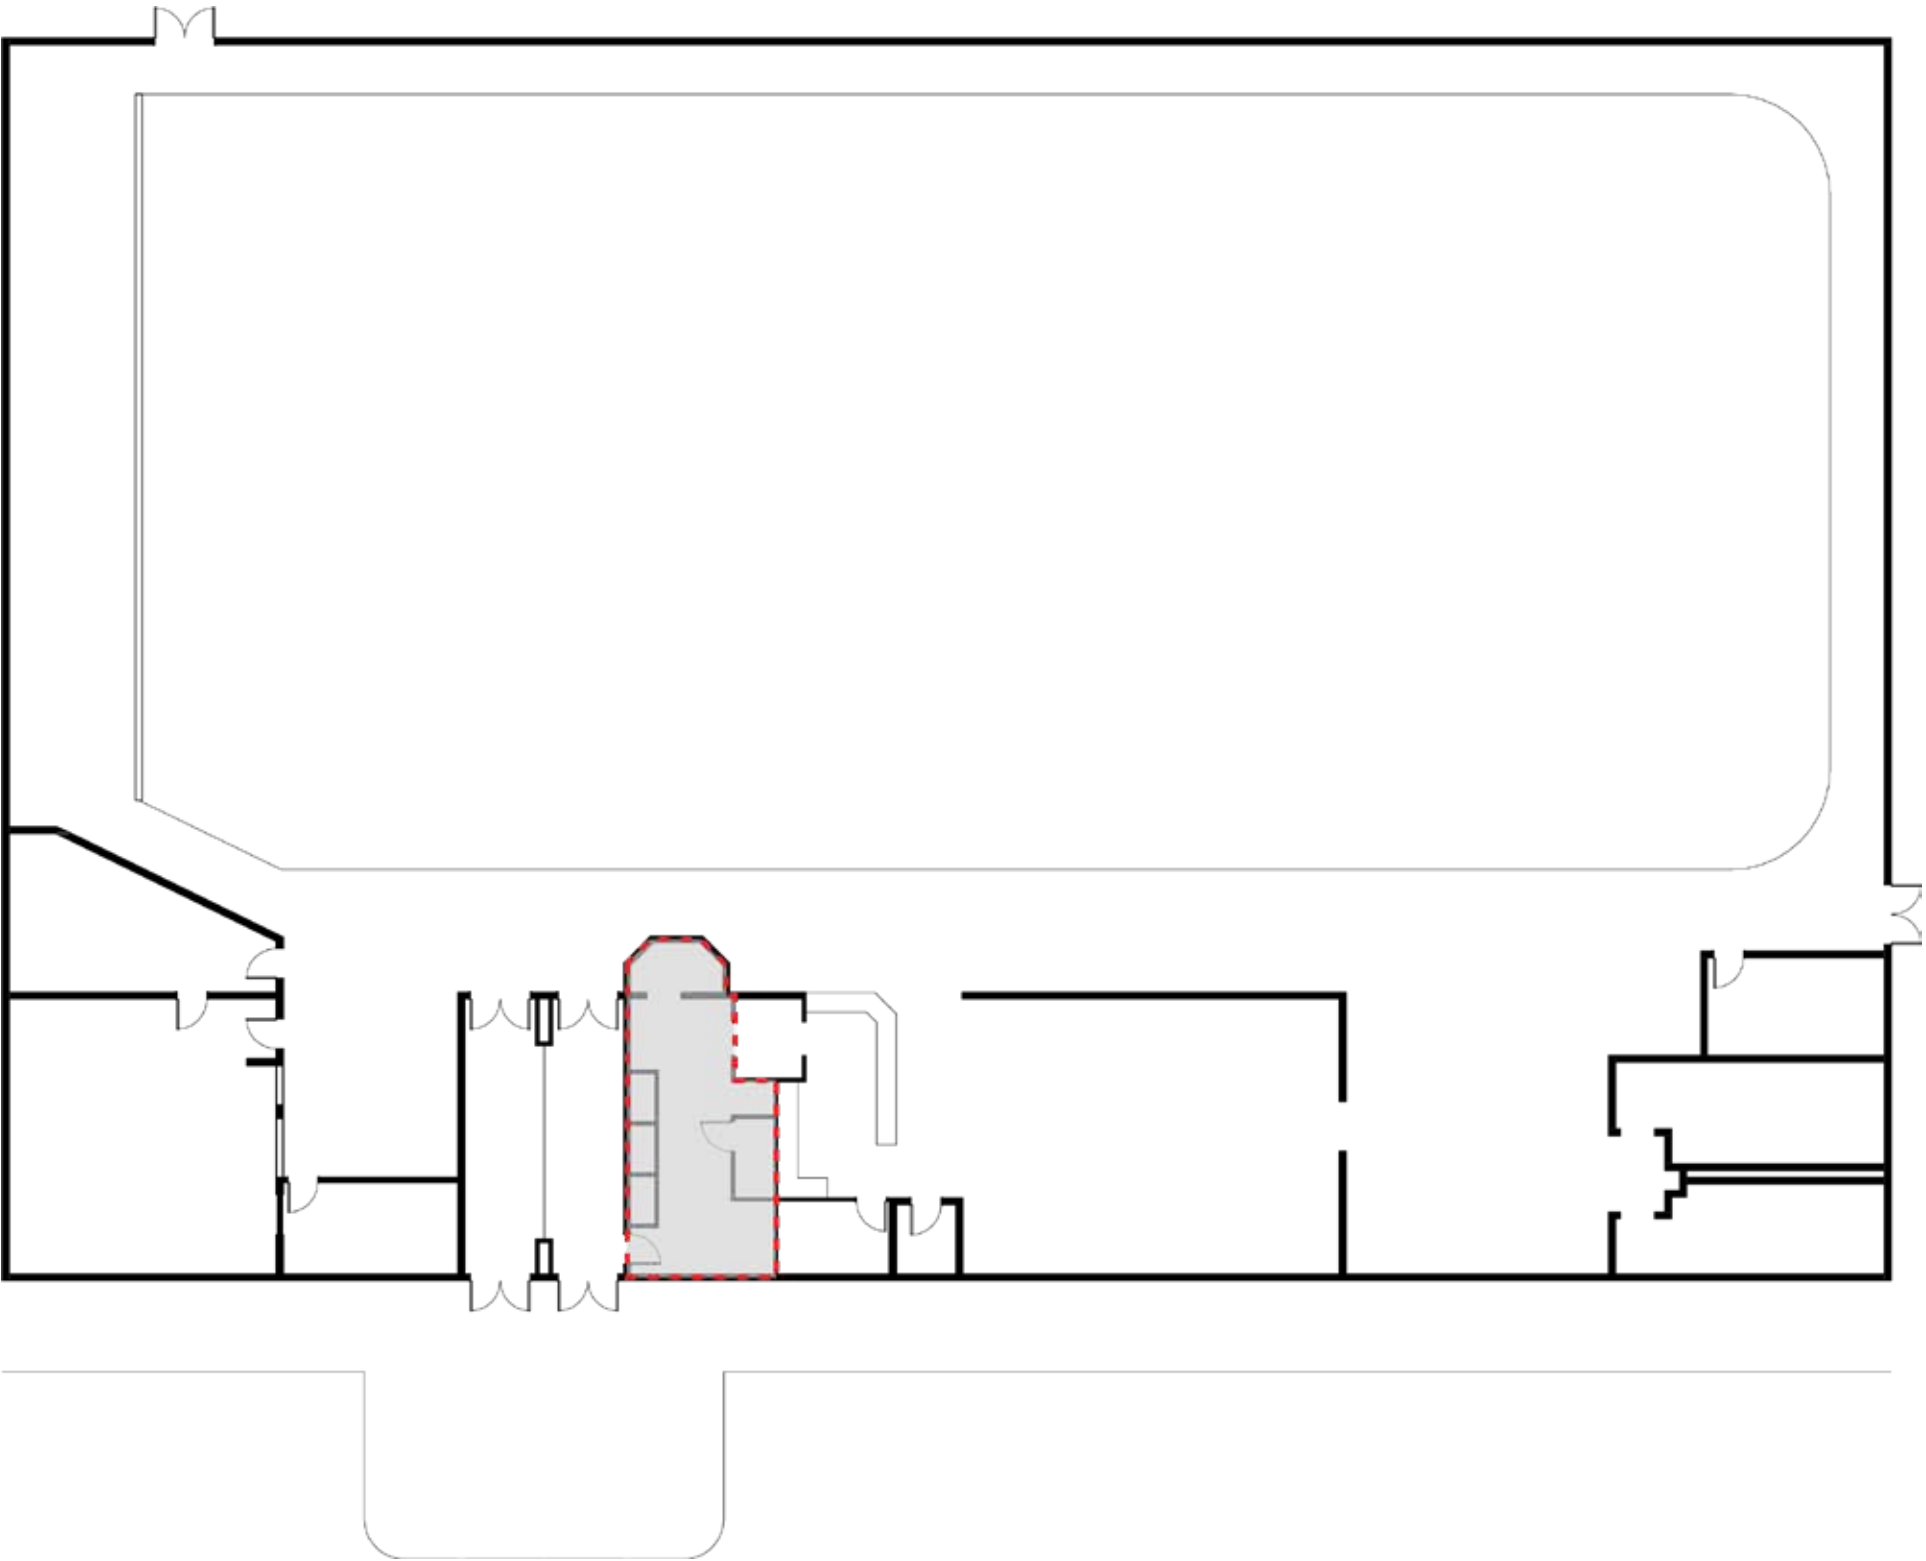
OFFICE

- The “pull” clearance on the office door does not meet the 18” clear dimension. The adjacent trophy display wall will need to be shifted by 10”. [2017 ICC A117.1 - Section 404]
- Door hardware on each of the three office doors will need to be replaced from knobs to levers. [2017 ICC A117.1 - Section 309]

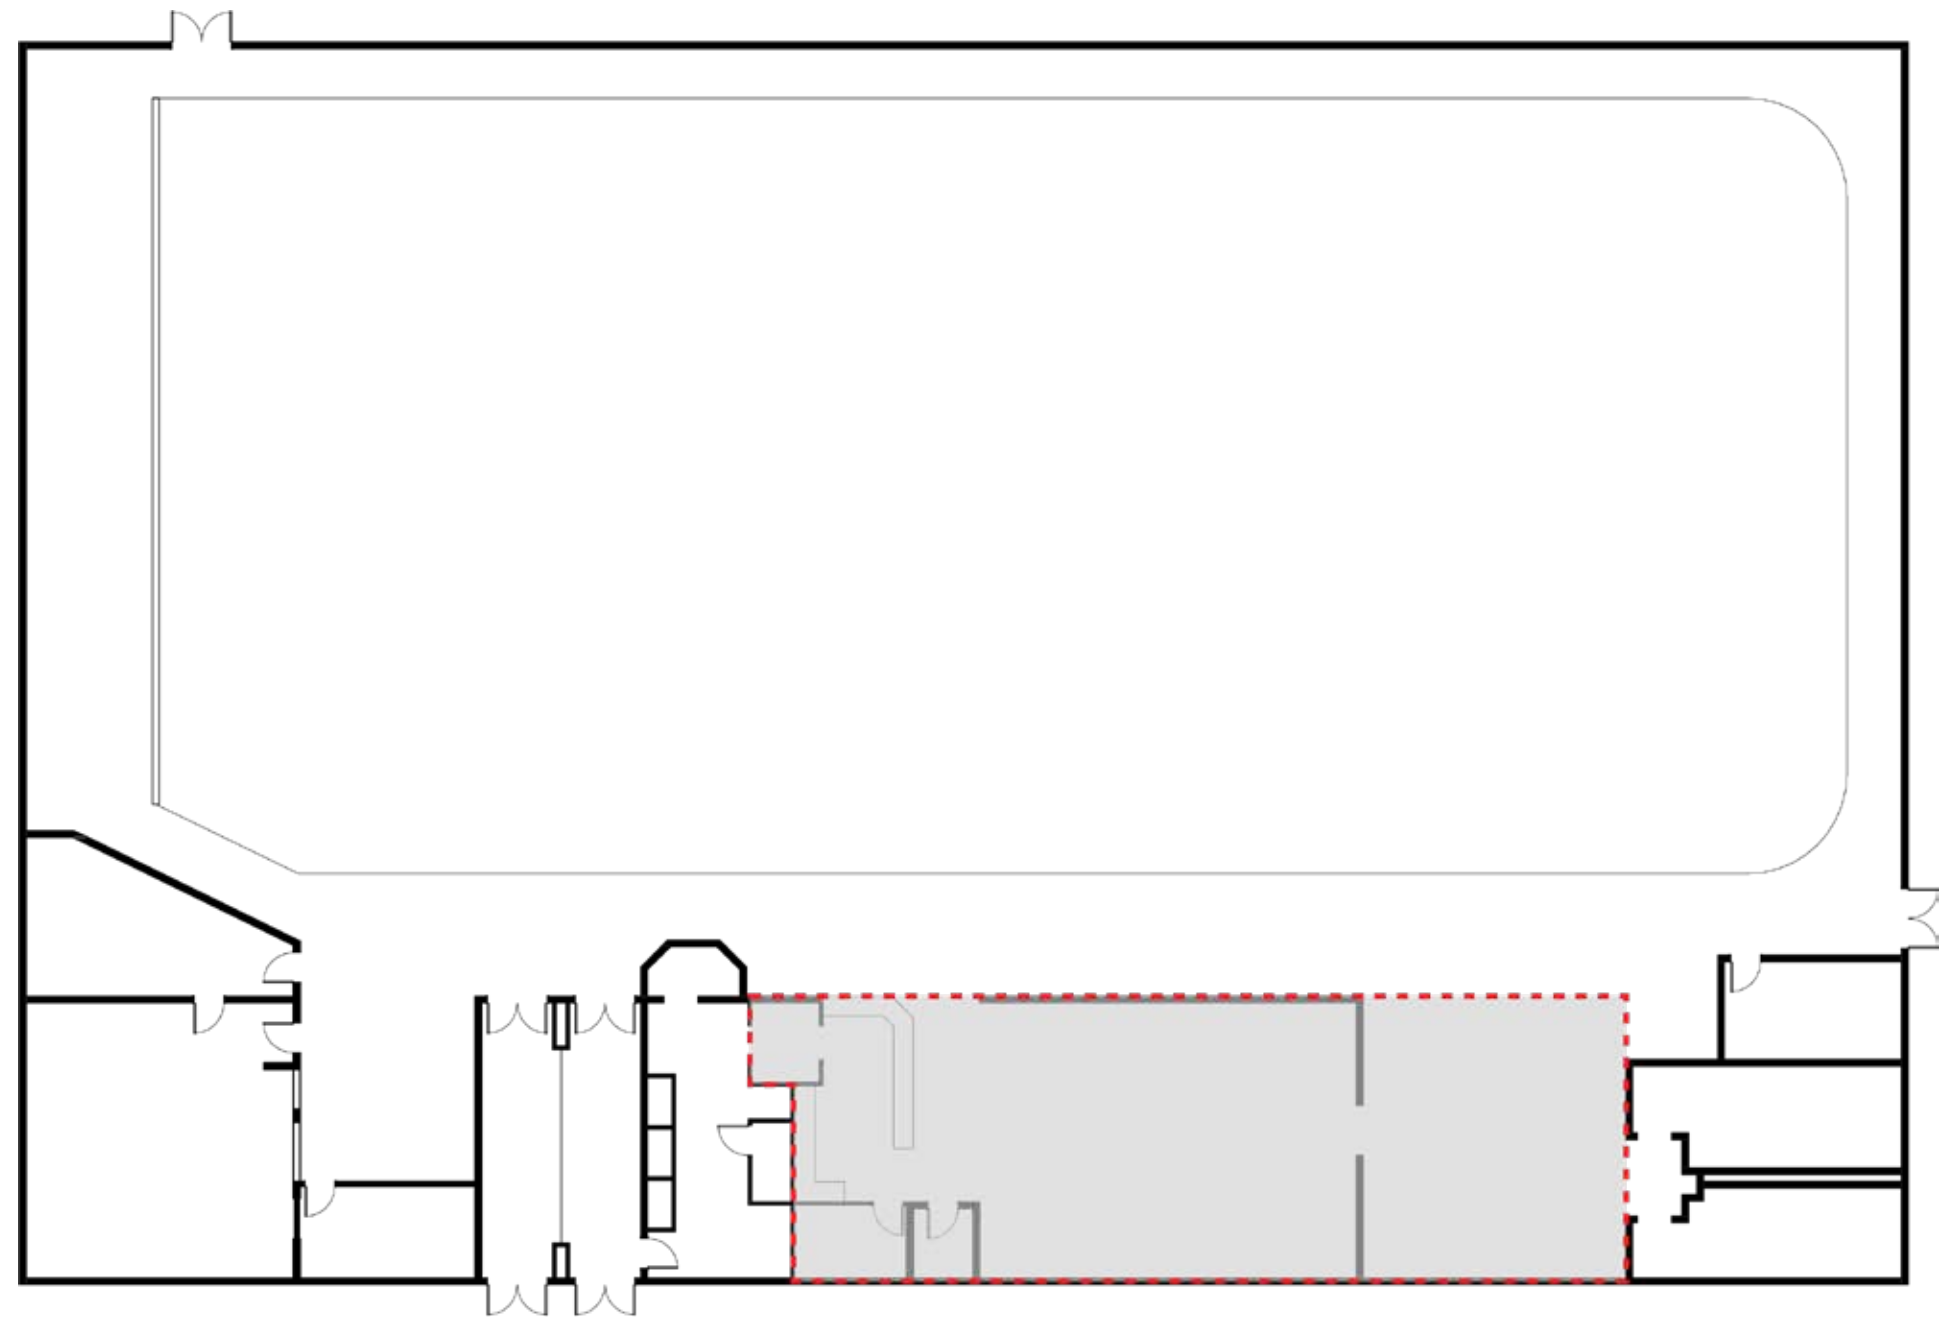
KITCHEN + DINING

- Service counter height exceeds the maximum height, will need to be lowered to no higher than 36". [2017 ICC A117.1 - Section 904]
- The kitchen hand wash sink exceeds the required 34" height maximum and does not have the proper insulation to protect against leg contact. [2017 ICC A117.1 - Section 606]
- The kitchen hand wash sink also requires 15" clear from the center of the fixture. The adjacent cabinet will require to be shifted. [2017 ICC A117.1 - Section 306]
- The kitchen hand wash sink requires a faucet fixture with levers rather than turn knobs. [2017 ICC A117.1 - Section 309]

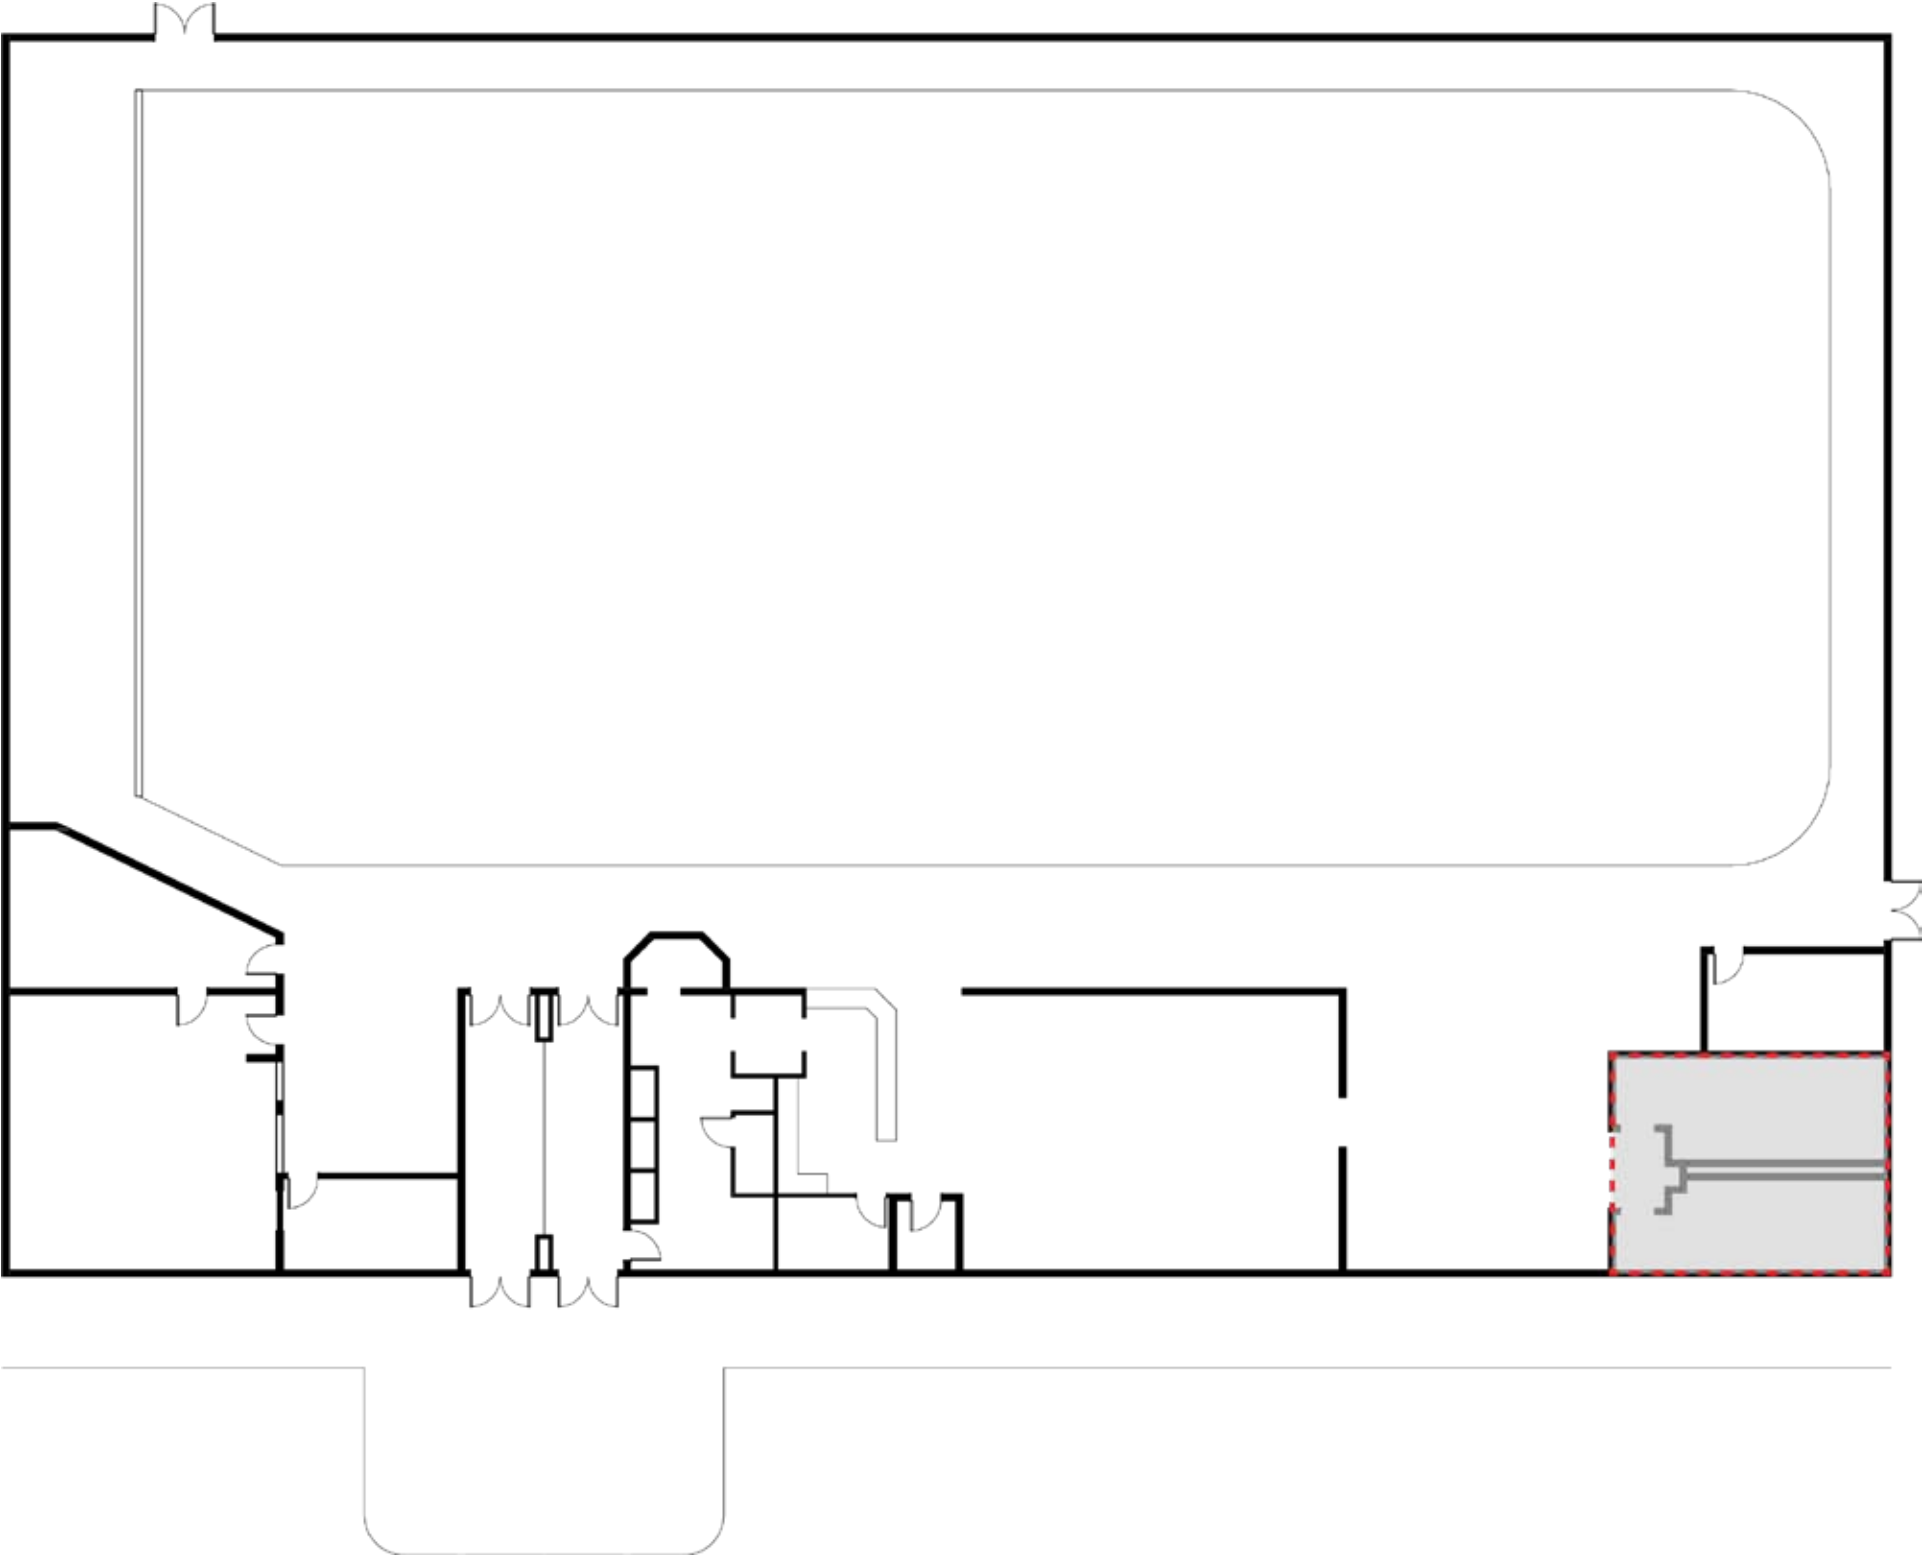
RESTROOMS

- Lavatory height in both mens and womens restrooms exceed the accessible height. Will need to be lowered at or below 34".
[2017 ICC A117.1 - Section 606]
- There is no way-finding signage for those with sight-limiting disabilities. [2017 ICC A117.1 - Section 703]

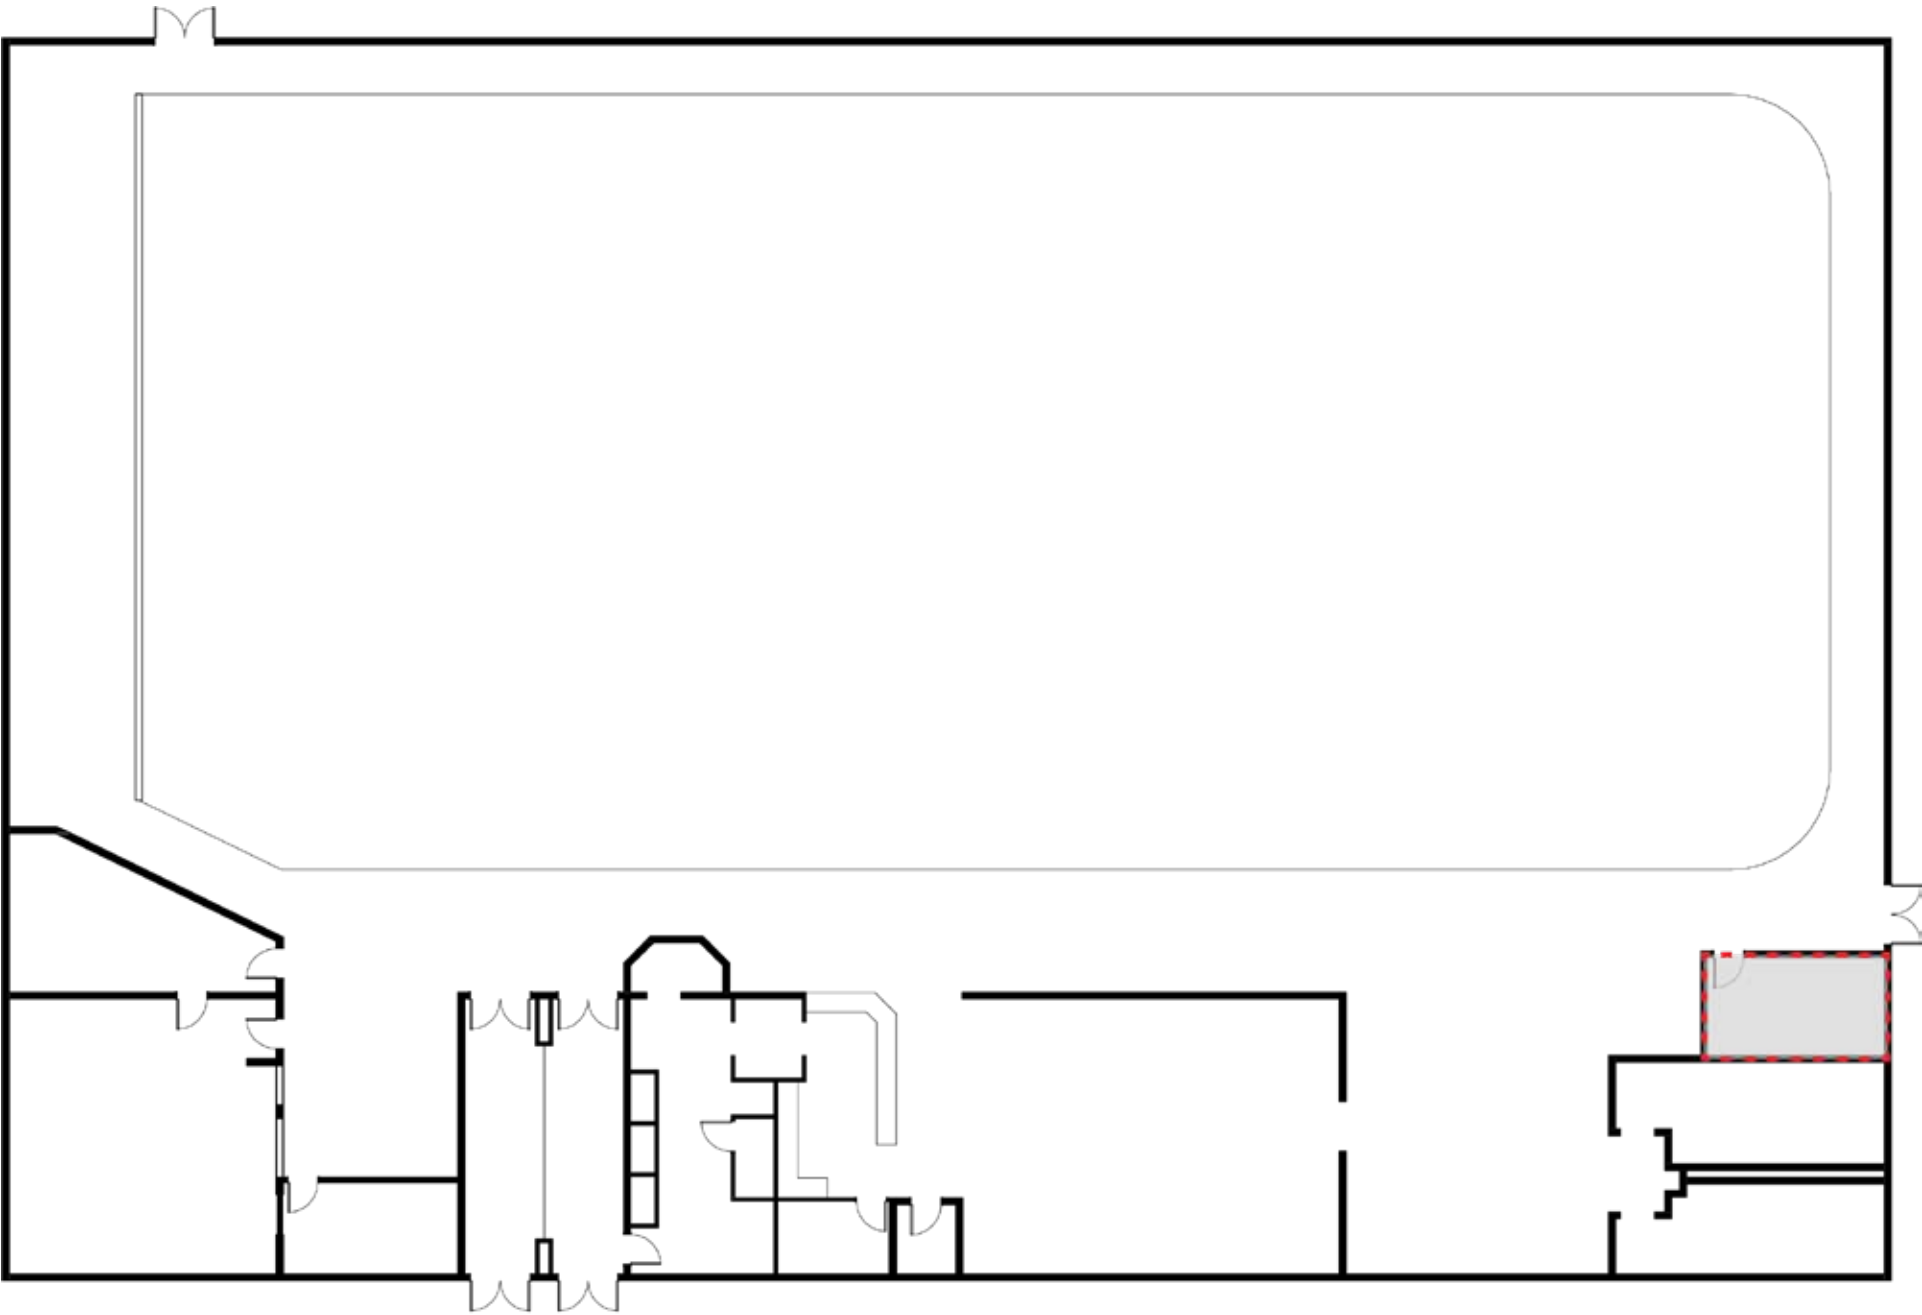
ELECTRICAL ROOM

- While there are no accessibility issues regarding the electrical room, there is a concern with the building seal at the electrical conduit.

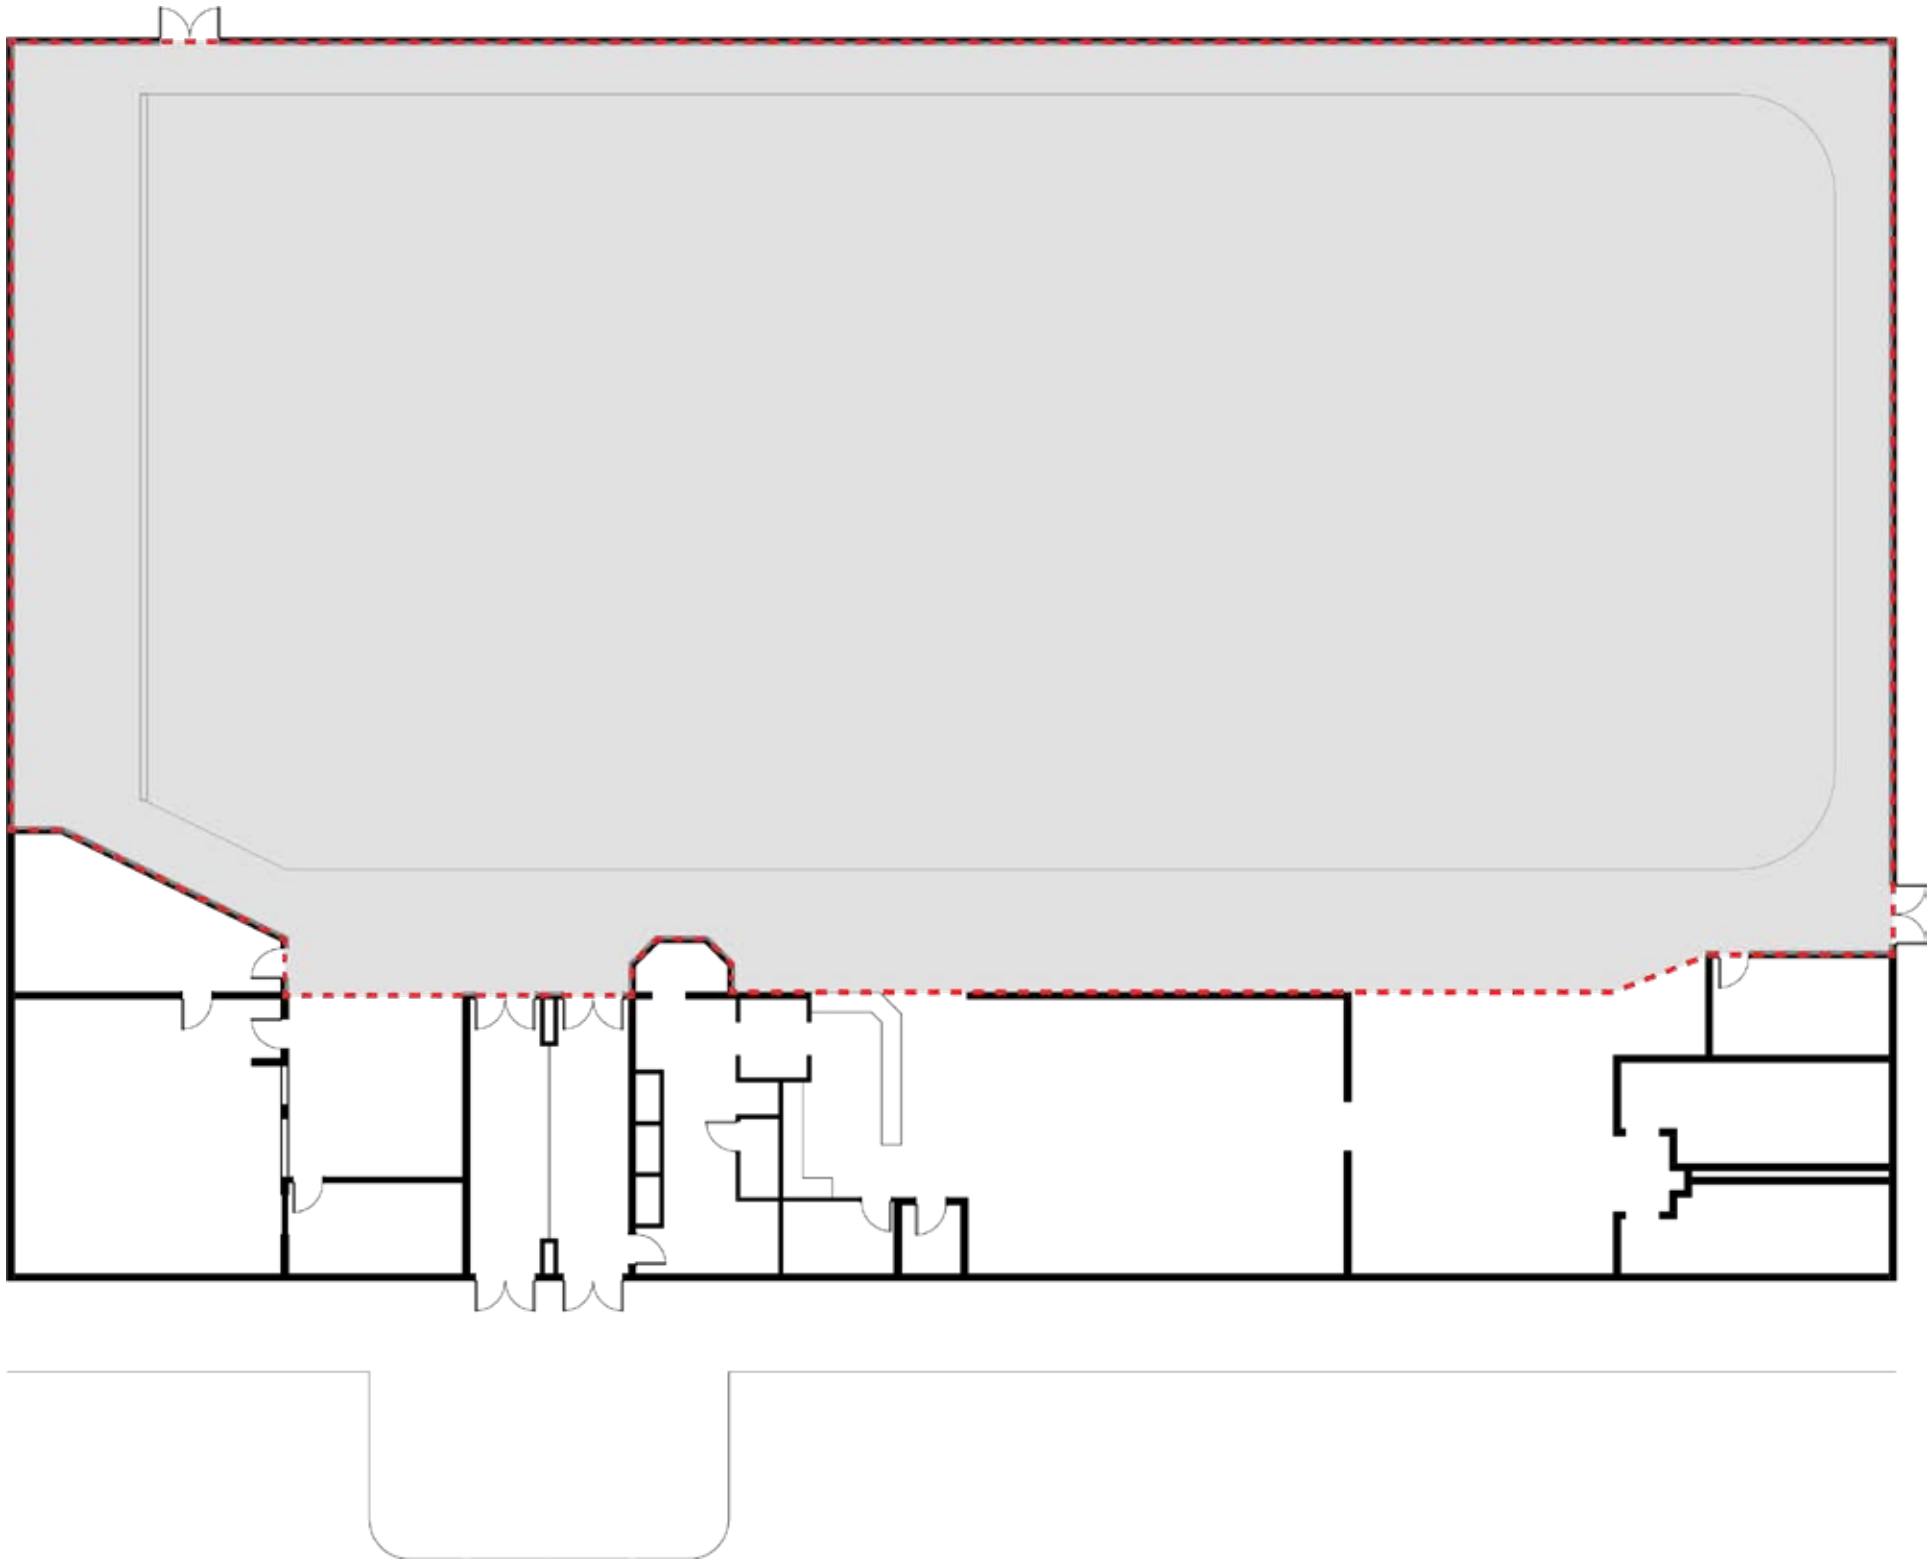
RINK

- Stage obstructs accessible route of egress to the north door.
[2017 ICC A117.1 - Section 402]
- There is no accessible route from the walkway to the rink floor. Solution to add proper accessibility could be to add a ramp or remove a portion of the raised floor. [2017 ICC A117.1 - Section 402]
- While not an accessibility issue, there is a 1"-2" gap between the rink floor and the edge of the walkway. This could potentially become a hazard. Add trim to prevent this issue.

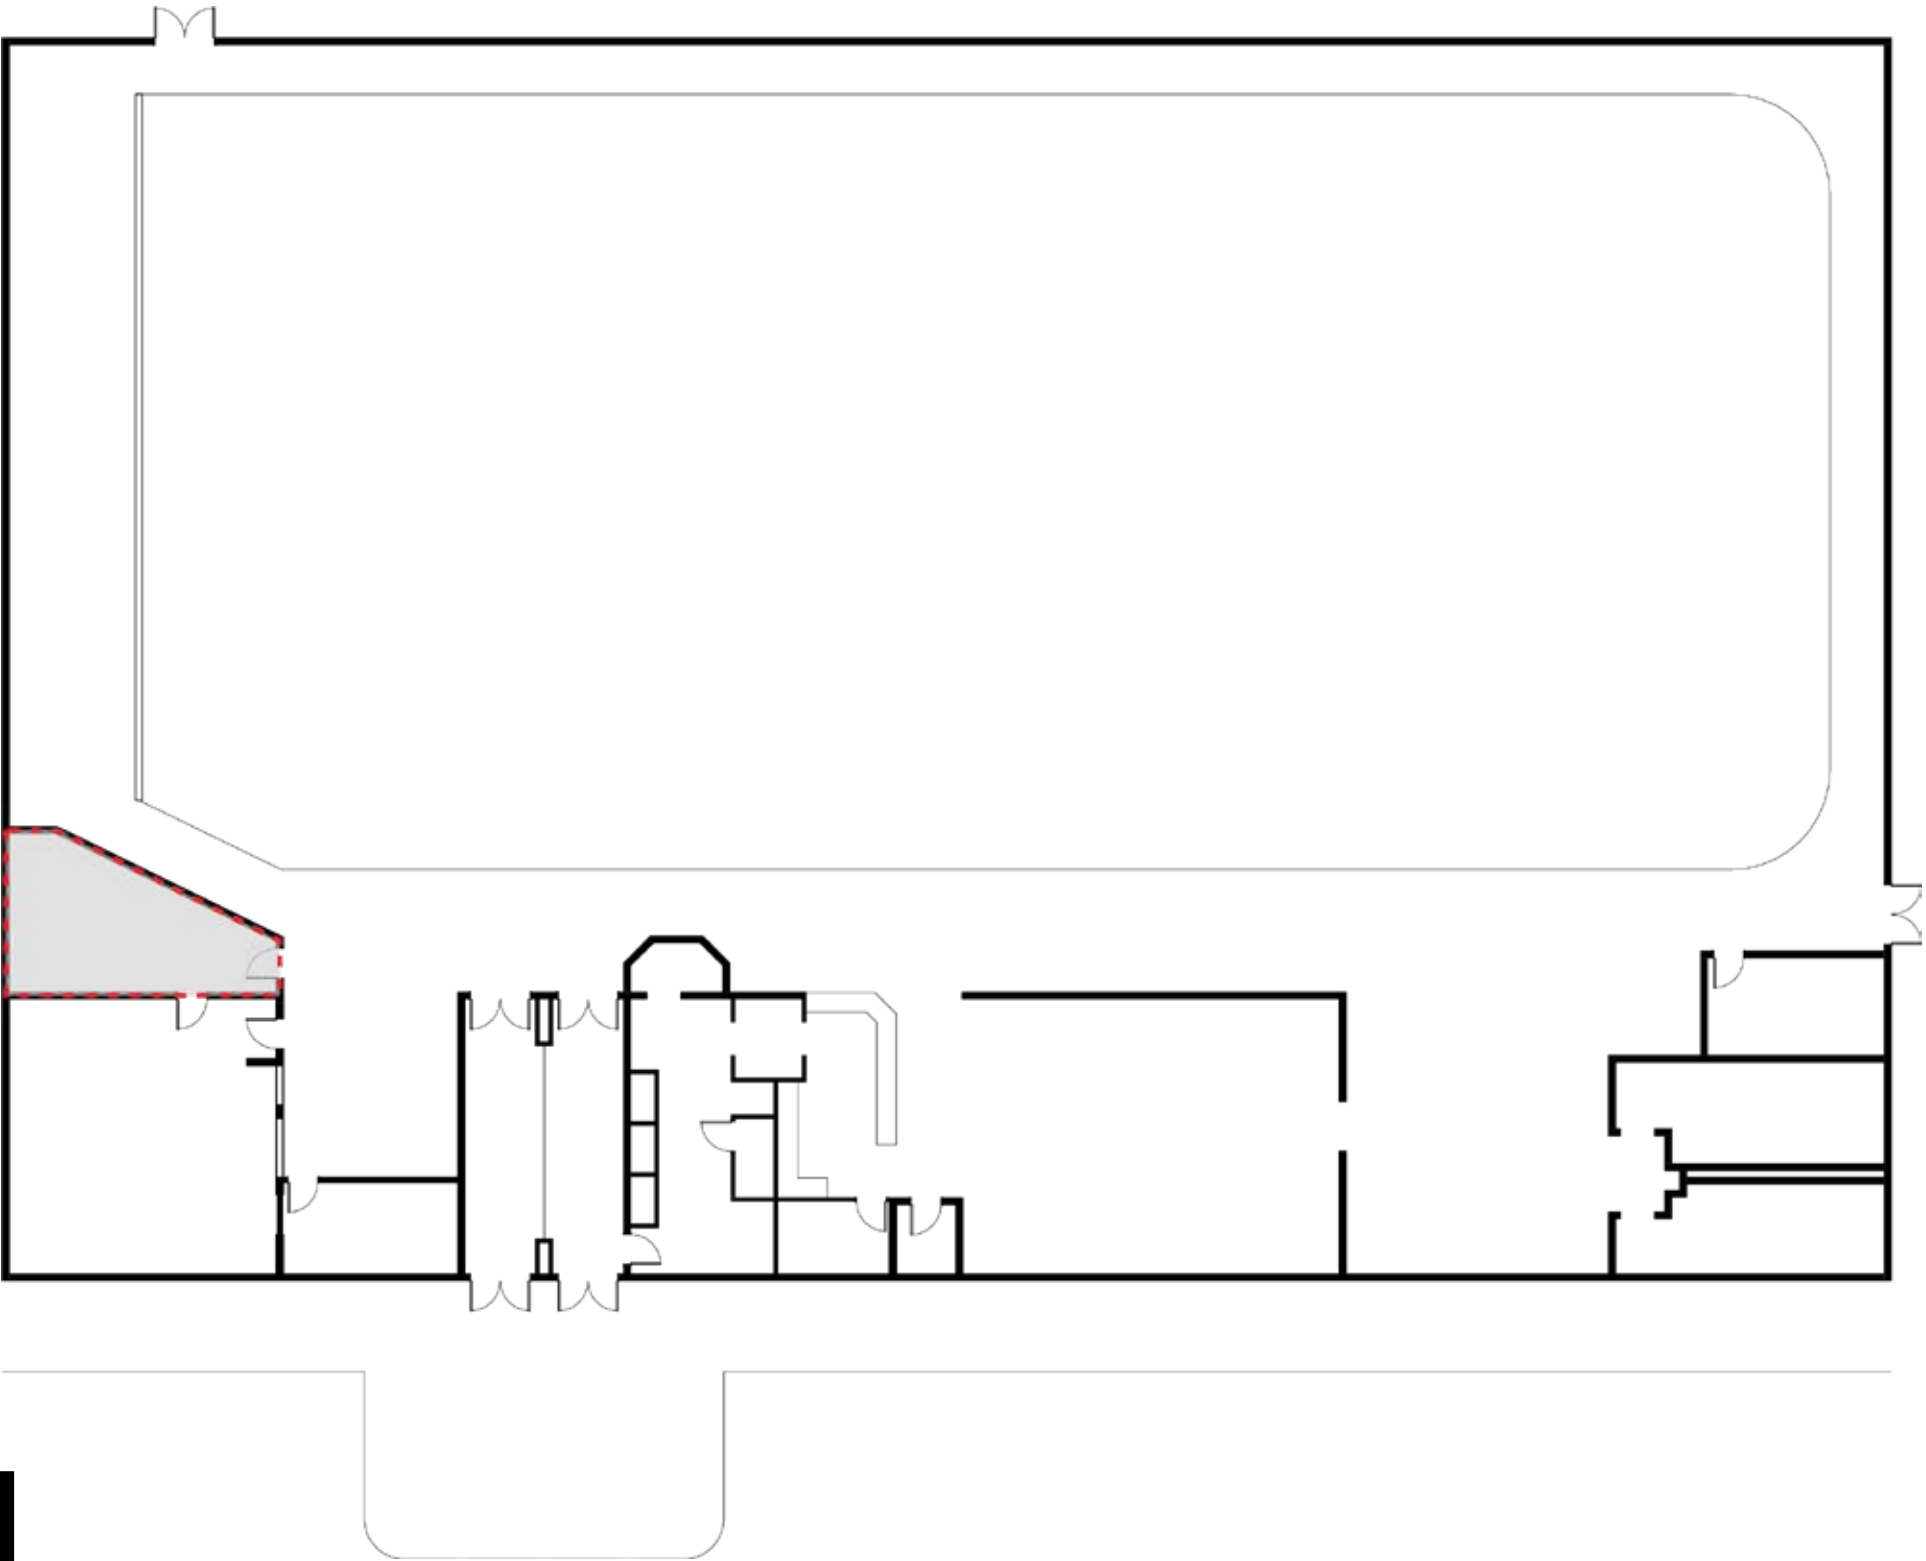
PARTY ROOM

- Accessible pull clearance on the entry door to the party room does not have the proper clearance. [2017 ICC A117.1 - Section 404]
- While not an accessibility issue, loose wire on the wall could be a problem.
- Door hardware on each of the two doors in the party room area will need to be replaced from knobs to levers. [2017 ICC A117.1 - Section 309]
