CITY OF DURHAM + DURHAM OUTDOOR AQUATICS STUDY

WHEELS FUN PARK RINK - CODE ANALYSIS

AUGUST 19, 2022

Wheels Recreation Center

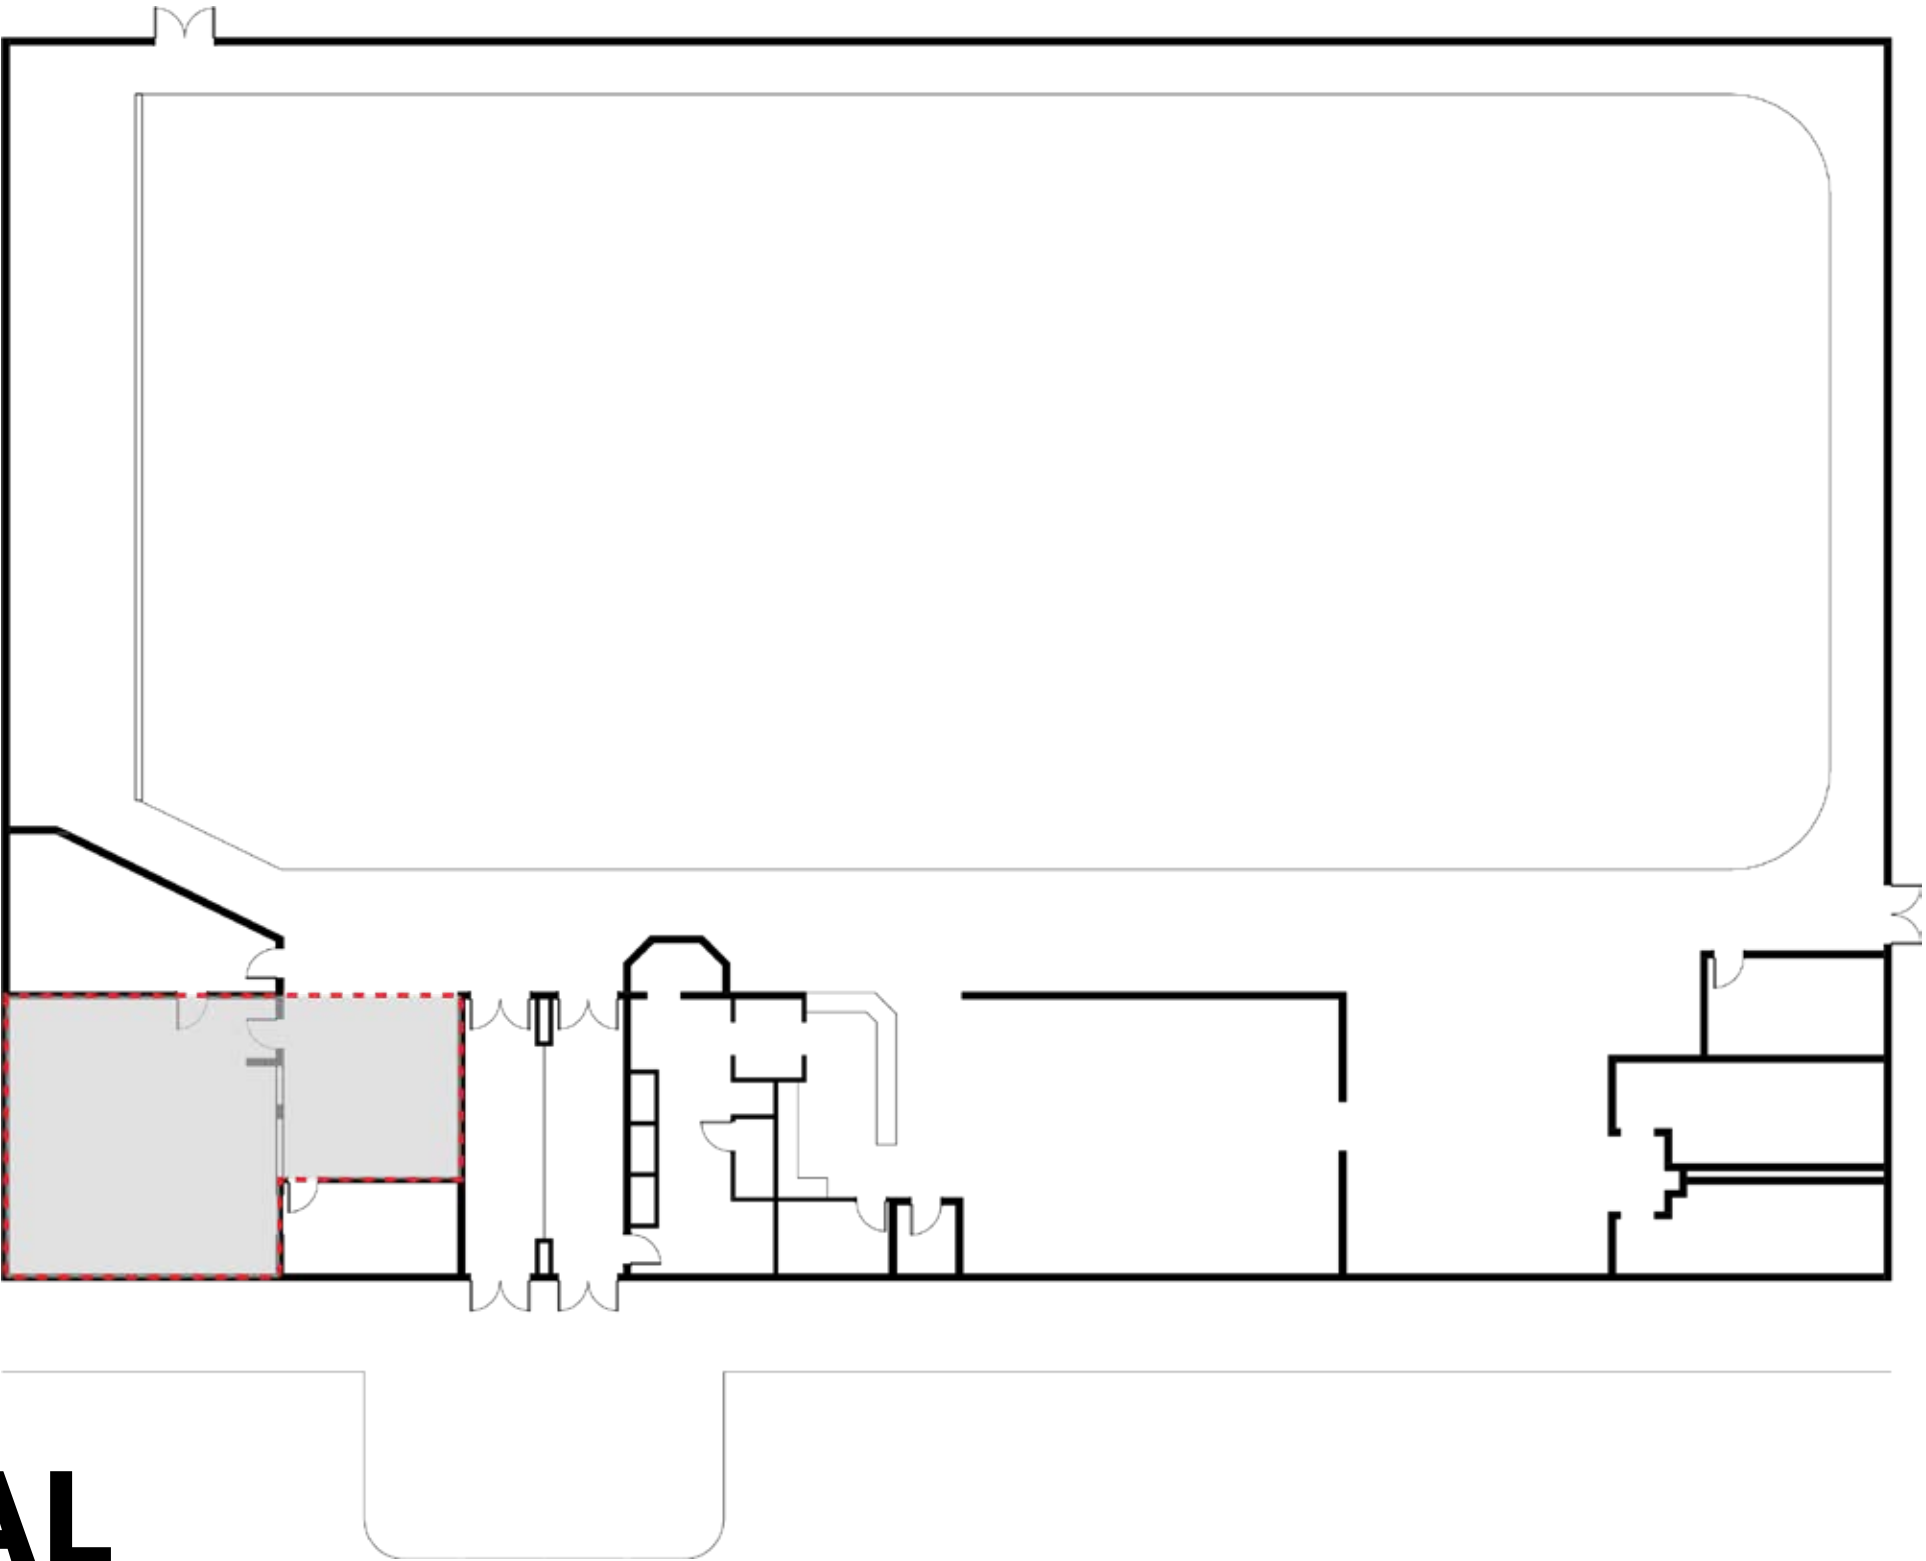
SKATE RENTAL

- The pull clearance inside the skate rental door does not meet accessibility standards. Wall will need to be shifted by at least 4". [2017 ICC A117.1 - Section 404]
- Door hardware on the door in the skate rental area will need to be replaced from knobs to levers. [2017 ICC A117.1 - Section 309]

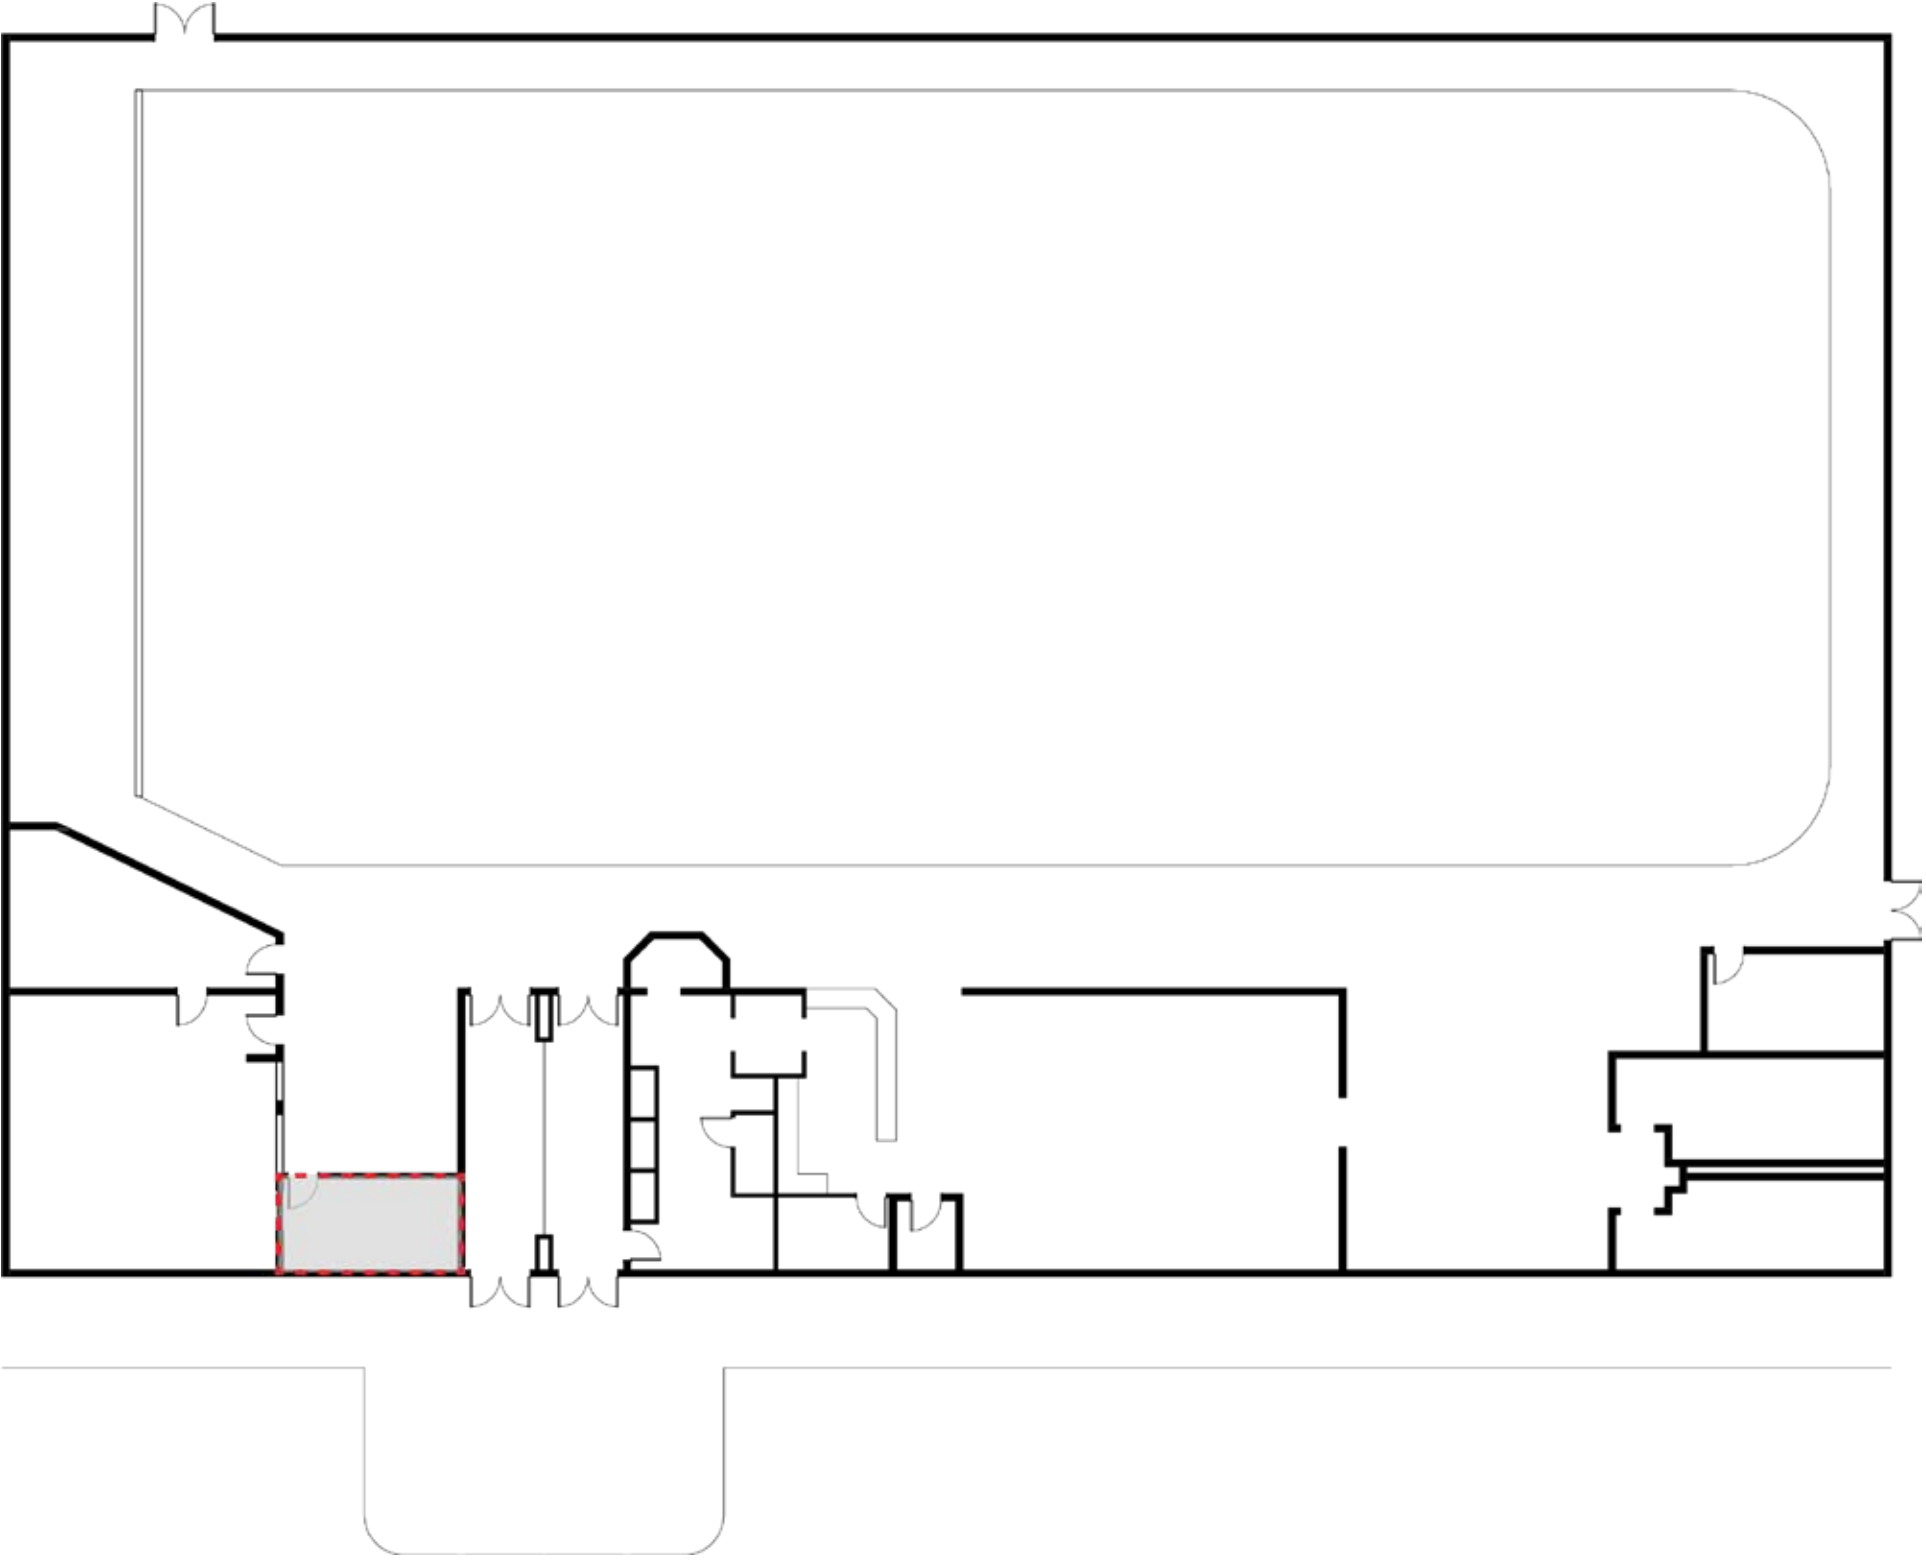
STORE

- The lights in the store area do not work.
- The wood siding base at the exterior wall should be investigated for possible mold and water intrusion.
- Door hardware on the door in the store area will need to be replaced from knobs to levers. [2017 ICC A117.1 - Section 309]
